# Marina Coast Water District

## 2018 Sewer System Management Plan Internal Audit

## SSMP- 2018 Internal Audit

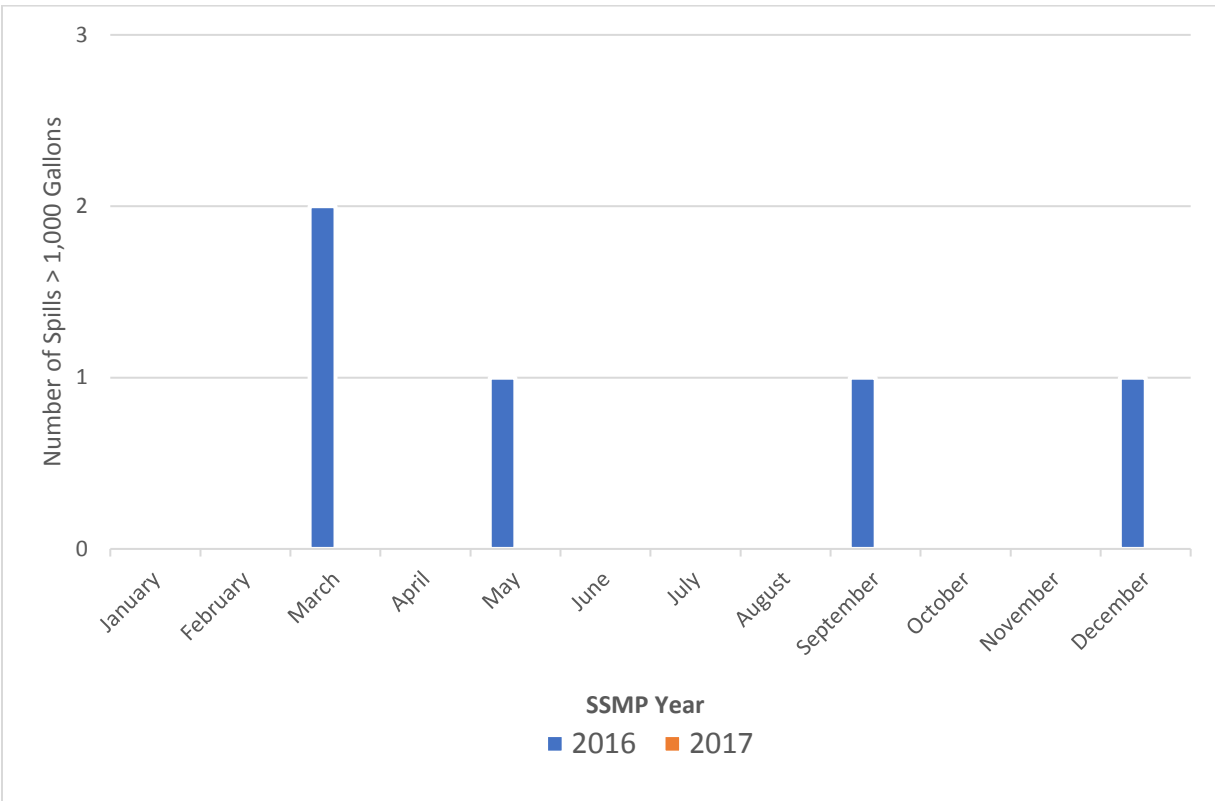
Number of Spills Greater Than 1,000 Gallons CY 2016-CY 2018

\*No spills in 2017 were greater than 1,000 gallons

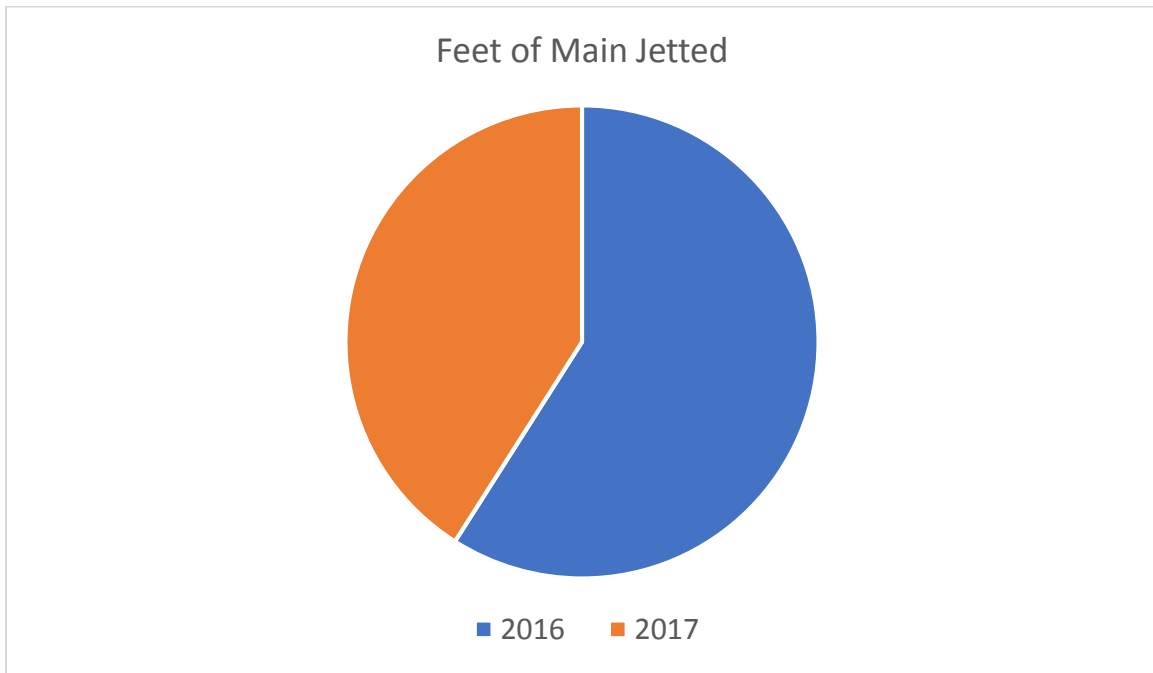
### Feet of Sewer Mains Jetted by Month

2016	Feet of Main Jetted	2017	Feet of Main Jetted
January	41,405	January	31,256
February	48,860	February	12,284
March	35,031	March	12,841
April	24,547	April	21,056
May	25,674	May	21,257
June	25,358	June	20,741
July	23,226	July	32,038
August	26,311	August	29,402
September	42,597	September	30,722
October	38,328	October	27,790
November	18,963	November	15,605
December	28,505	December	7,973
<b>Total Feet Jetted</b>	<b>378,802</b>	<b>Total Feet Jetted</b>	<b>262,966</b>

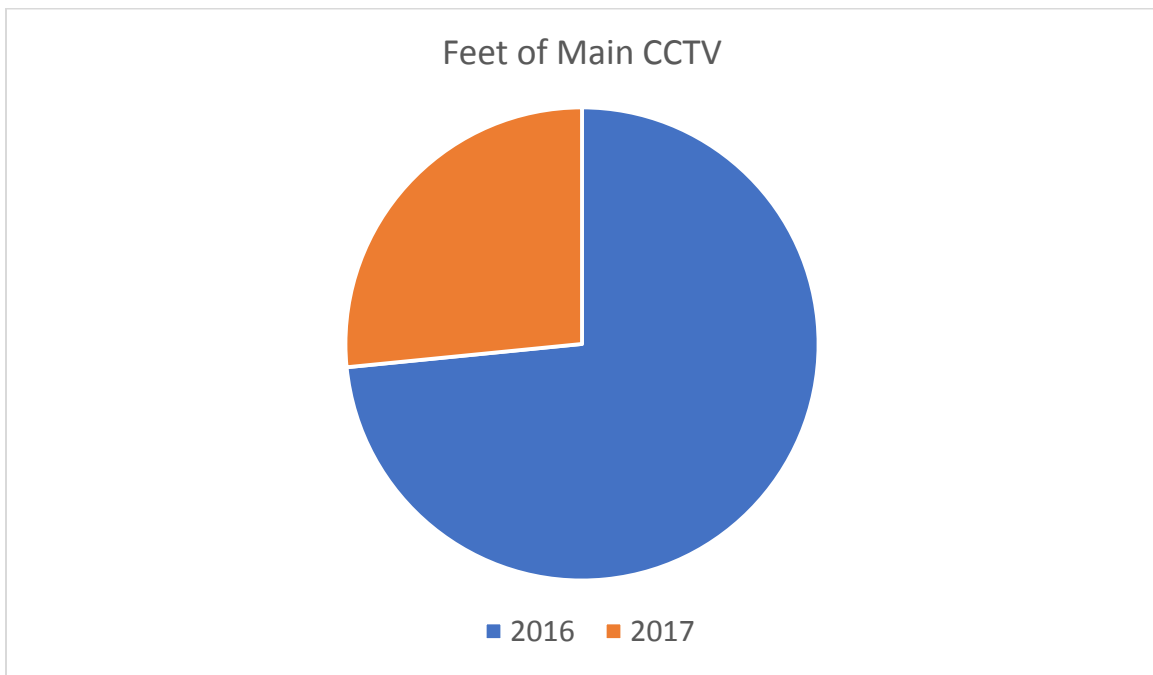
### Feet of Sewer Mains CCTV by Month

2016	Feet of Main CCTV	2017	Feet of Main CCTV
January	2,282	January	5,382
February	15,398	February	1,592
March	12,054	March	5,666
April	15,918	April	5,844
May	9,771	May	2,766
June	10,600	June	6,036
July	1,152	July	347
August	12,808	August	773
September	4,192	September	5,351
October	14,268	October	8,277
November	14,202	November	0
December	3,378	December	0
<b>Total Feet Jetted</b>	<b>116,020</b>	<b>Total Feet Jetted</b>	<b>41,983</b>
