# Marina Coast Water District Sewer Master Plan

**AKEL**  
ENGINEERING GROUP, INC.

**SEWER MASTER  
PLAN**

May 2020

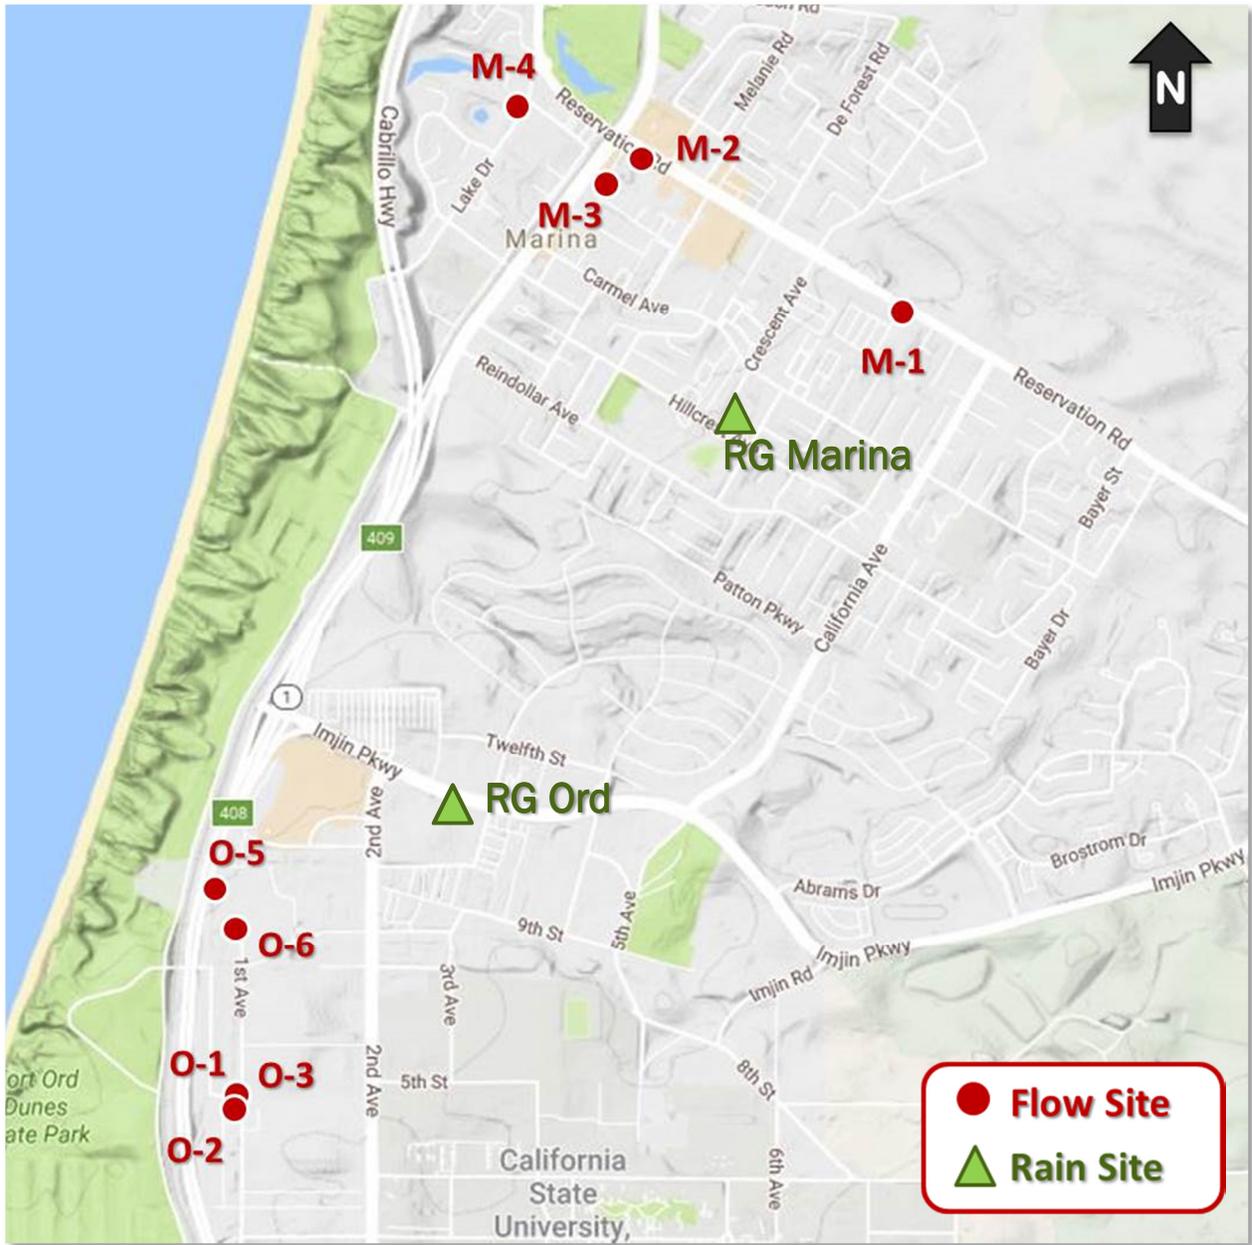
Figure 1-1. Map of Flow Monitoring Sites

The FM sites and associated basins (including basin flow equations) are listed in Table 1-1. The FM sites and associated basins and shown in Figure 1-1 and Figure 1-2, respectively. Detailed descriptions of the individual flow monitoring sites, including photographs, are included in Appendix A.

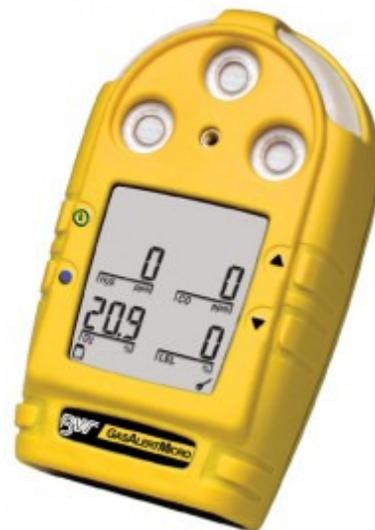
Photo 2-2. Typical Personal Four-Gas Monitor

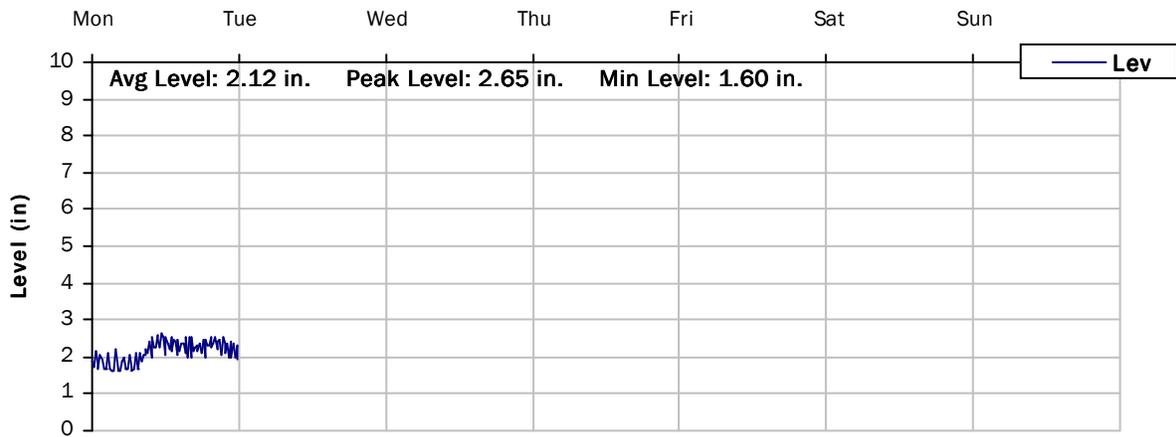
**Weekly Level, Velocity and Flow Hydrographs**

**2/20/2017 to 2/27/2017**

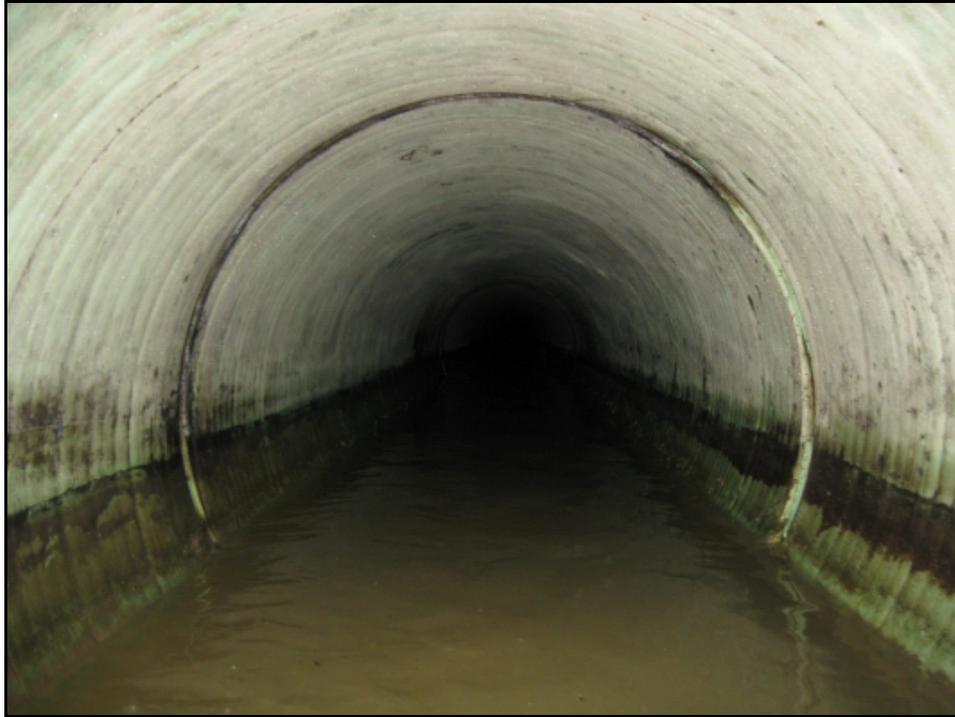
**Effluent Pipe**

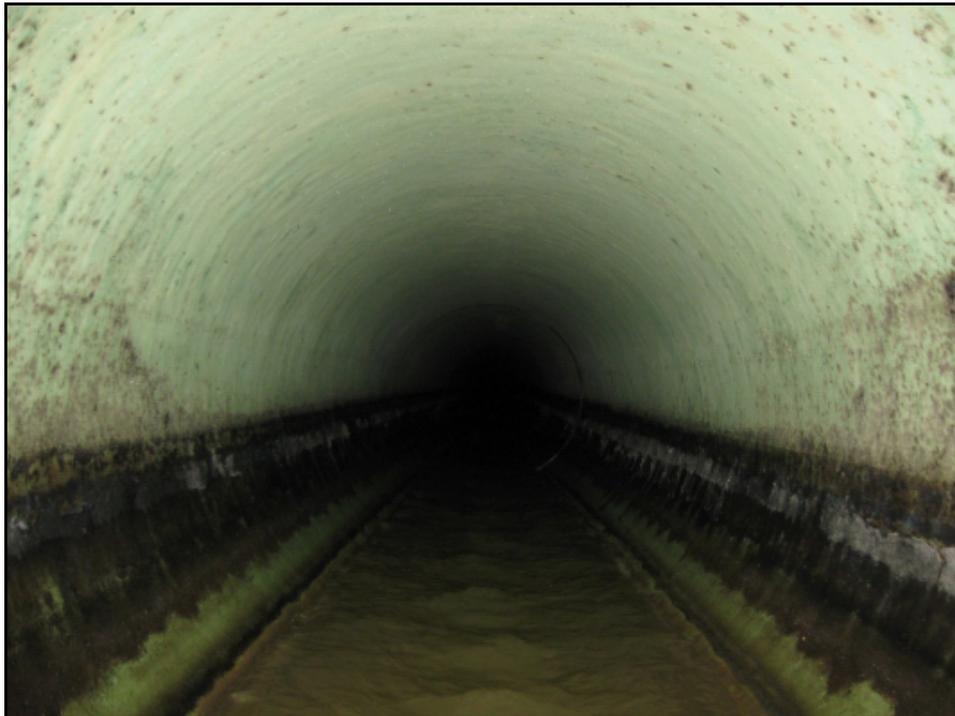
**North Influent Pipe**

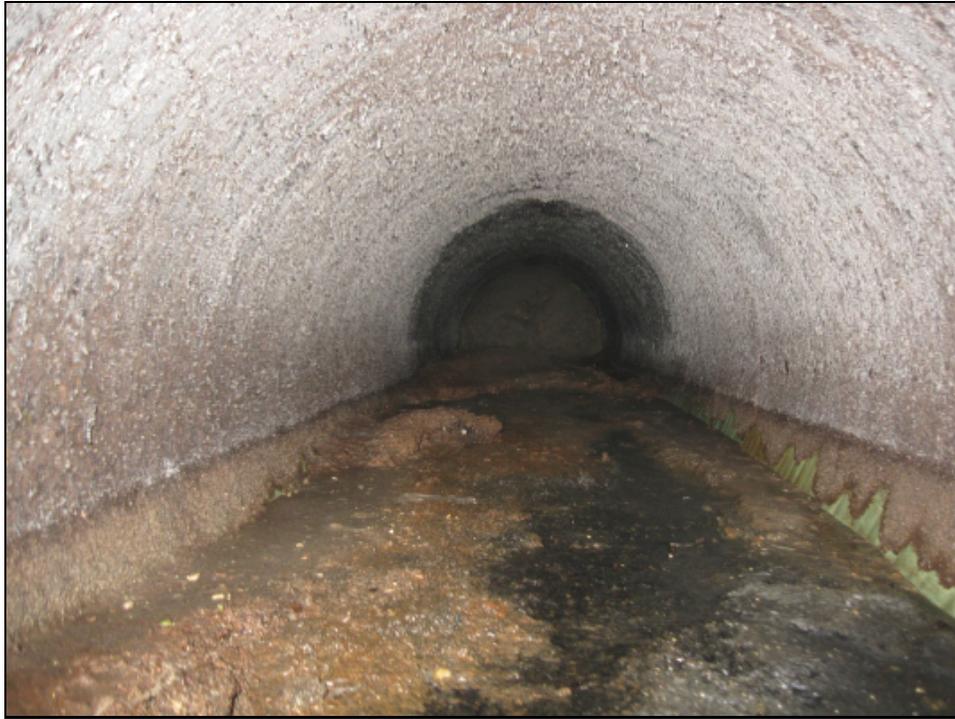
**East Plugged Pipe**

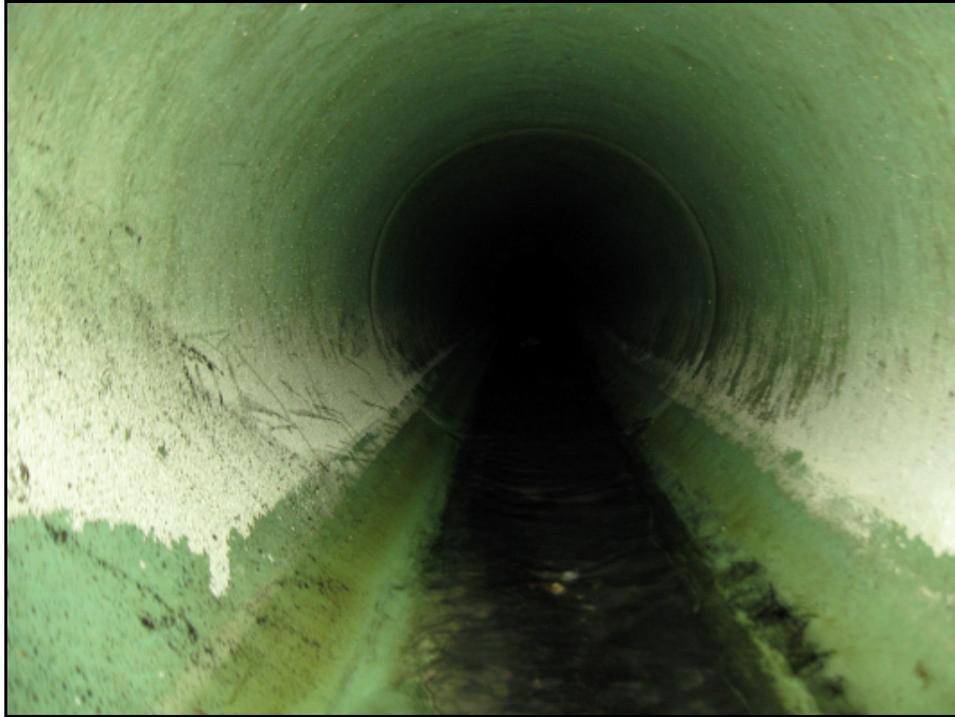
**Effluent Pipe**

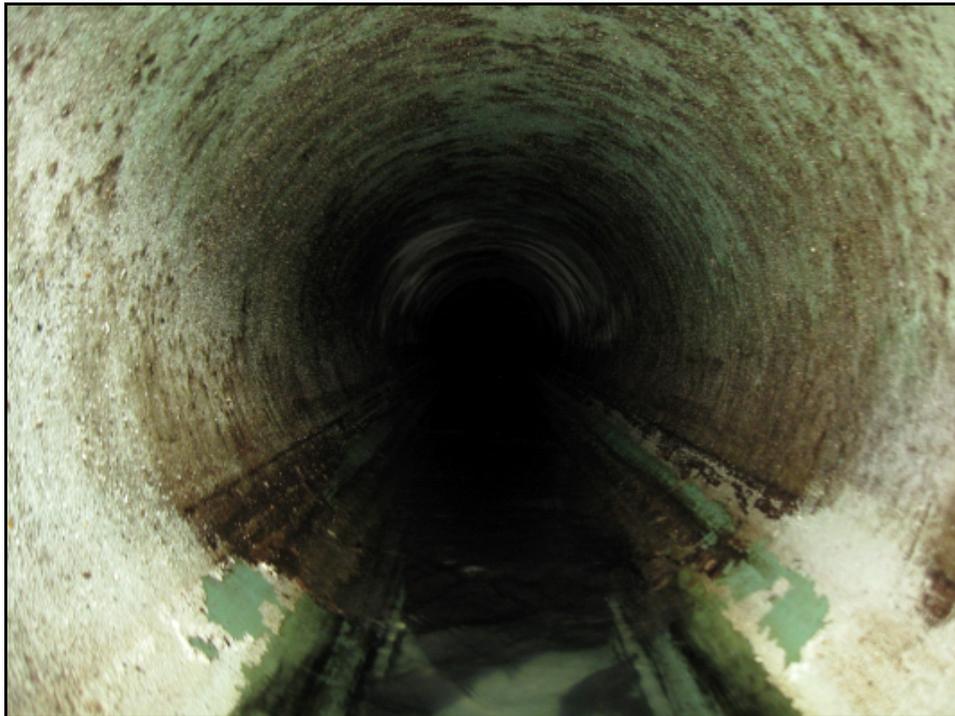
**North Inflow Pipe**

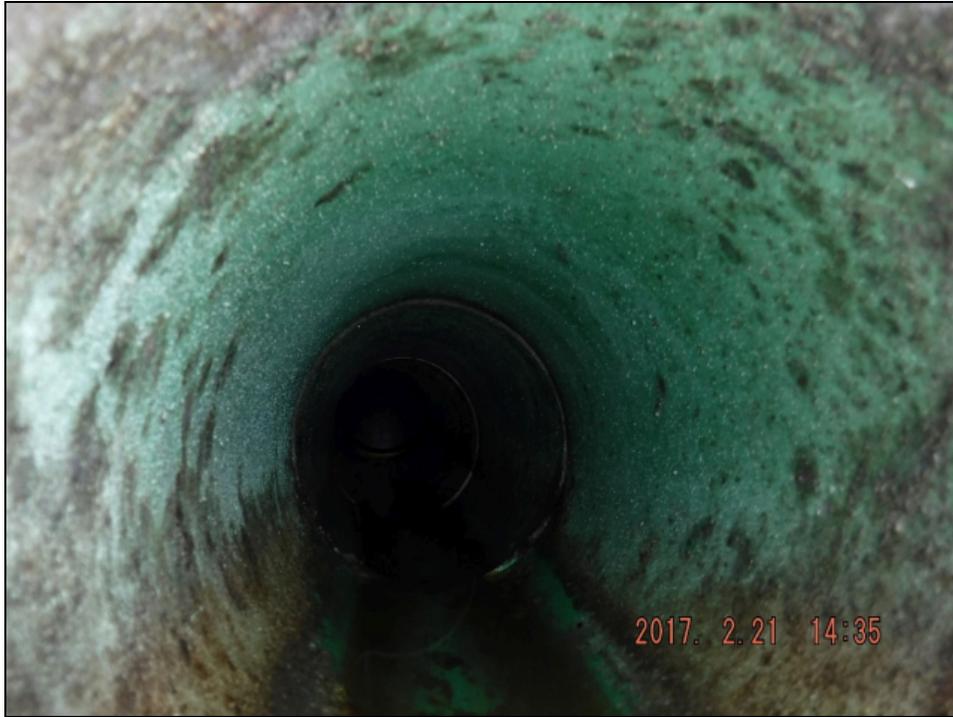
**East Influent Pipe**

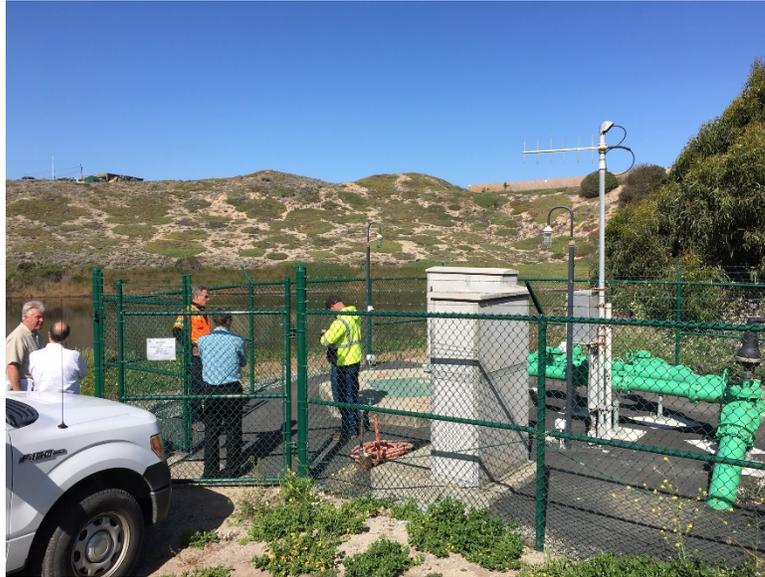
### 4.1 DUNES

The Dunes Lift Station is a wet well submersible lift station with no building. Valves and pipes are above grade. Electrical cabinets are also above grade. The entire lift station is fenced in.

The Dunes Lift Station is located at Dunes Drive, next to the Marina Dunes Resort, west of Highway 1. The lift station was originally built in 1969, with the pumps upgraded in 1987. Capacity with both pumps running is 0.79 MGD.

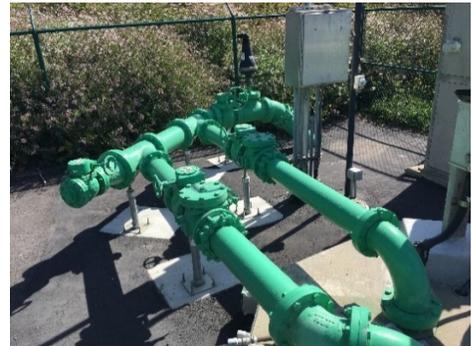
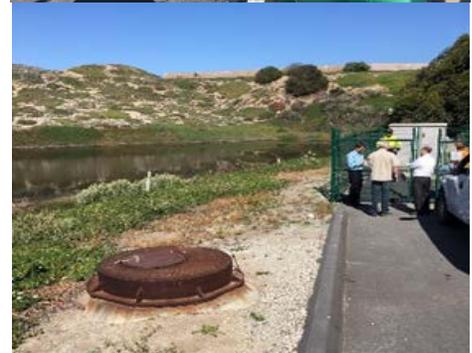
Component
Discharge piping and valves
Score
2
Reason
Recently upgraded and functions well, though access is difficult to remove the valves with a lifting device.

Piping was replaced from the flange out of the wet well up to the ductile iron force main discharge at the intersection nearby. The original pipe routing went up to the old treatment plant, and came back down the hill to a gravity feed. When two pumps were on and stayed on too long it would end up flooding a cleanout near a residence, through the lateral. The piping was rerouted through check valves to a manhole approximately 40 feet near the wet well, which adds capacity.

- Since the valves are located behind the wet well, access is difficult for O&M staff to remove the valves with a lifting device (See Piping / Valves in Section 4.1.1).

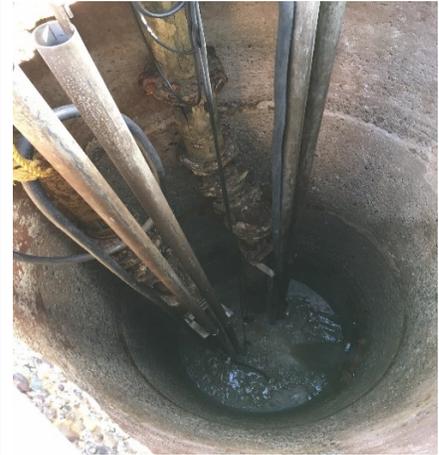
Component
Pump Guide Rails
Score
1
Reason
Appears to be in good condition with no signs of corrosion

Inside the wet well, the stainless steel pump lifting guide rails appear to be in good condition.

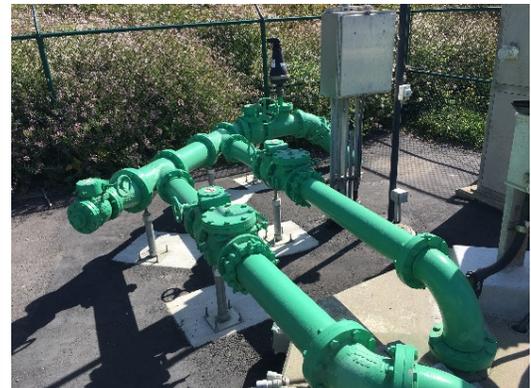
Component
Pipe and Equipment Support
Score
1
Reason
Appear to be in good condition. No issues noted by the operator.

Pipe and equipment support appears to be new and in good working condition.

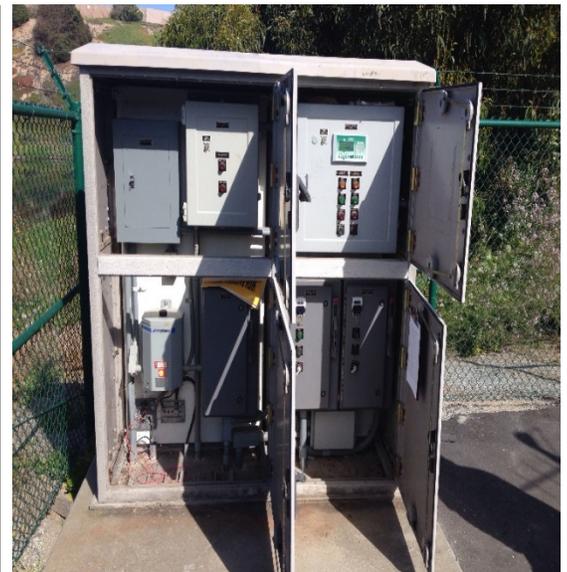
Component	Score	Reason
100 Amp Receptacle for Portable Generator	1	No issues observed.
Component	Score	Reason
Pump Motor Starters	1	No issues observed.
Component	Score	Reason
Pump Control Panel	1	No issues observed.
Component	Score	Reason
480-240/120-volt step-down transformer	1	No issues observed.
Component	Score	Reason
240/120-volt lighting panel	1	No issues observed.
Component	Score	Reason
NEMA 3RX fiberglass enclosures	1	No issues observed.

A 100-amp receptacle for connecting a portable generator is mounted to the exterior of this enclosure. Two pump motor starters, a pump control panel, a 480-240/120-volt step-down transformer, and a 240/120-volt lighting panel are located in another fiberglass outer enclosure located on top of the wet well slab. While the

NEMA 3RX fiberglass enclosures are moderately weathered, the individual painted steel components inside show no signs of weathering or corrosion.

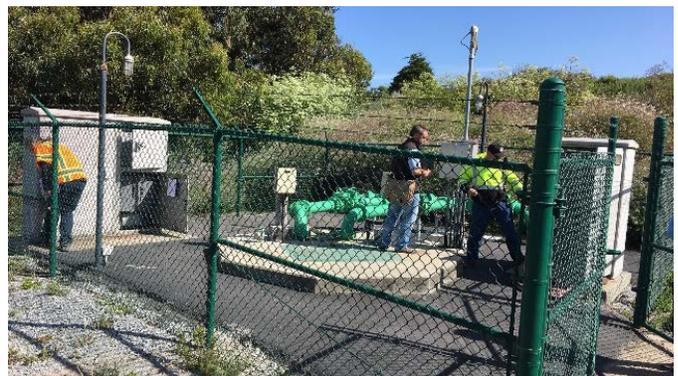
Component
Fence
Score
1
Reason
Appear to be in good condition. No issues from operator.

Security issues have not been a problem at this site, either with theft or vandalism. The lift station is now screened by a coated chain linked fence and three strands of barbed wire at the top after corrosion issues addressed in the 2005 Wastewater Collection System Master Plan<sup>1</sup>.

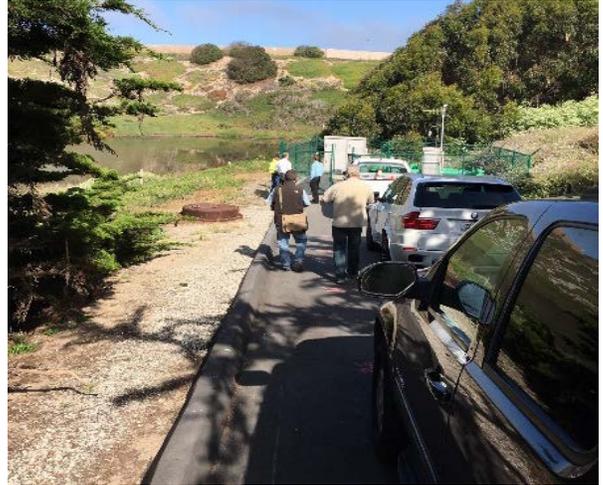
Component
Road Space
Score
2
Reason
There is not sufficient space for vehicle turnaround, but the short length of the access road makes this a minor issue.

The site is paved and is adjacent to an existing storm water detention pond. There is no space for vehicle turnaround, requiring vehicles to exit in reverse, uphill along the access drive onto the street. There is no parking space other than the access road.

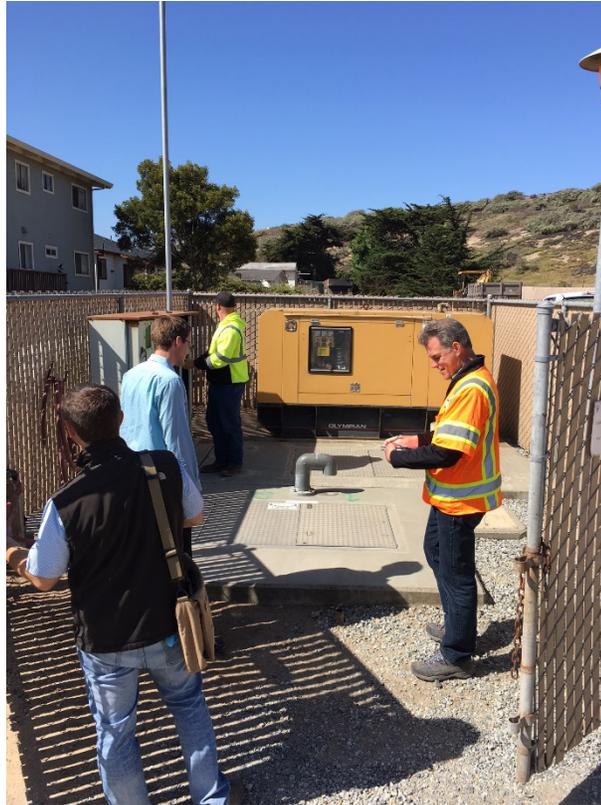
## 4.2 SAN PABLO

The San Pablo Lift Station is a wet well submersible lift station with no building. Valves and pipes are below grade. Electrical cabinets are above grade. The entire lift station is fenced in.

The lift station is located next to 180 San Pablo Court. A two-story apartment building and some single family homes are located in close proximity to the lift station. The lift station was originally built in 1969 and had a major upgrade in 2000.

For Additional Photo - See Overview Photo at the beginning of Section 4.2

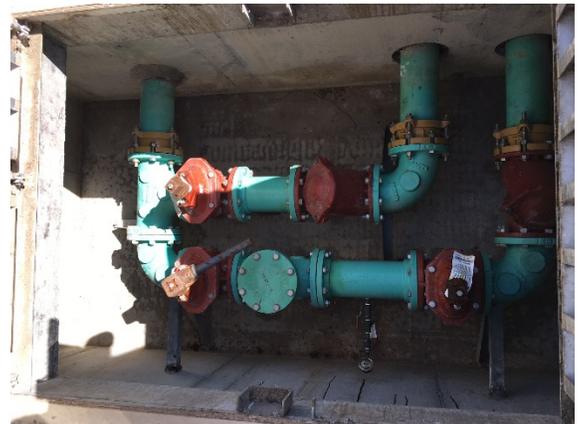
Component
Valve Vault
Score
2
Reason
Valves and piping are in good condition, but valve vault has short clearance to fences.

Within the valve pit, a check valve and gate valve are provided on each discharge pipe. The discharge pipes then combine to form a common 6-inch force main leaving the lift station to the west. The valve pit is located behind the wet well at the rear of the site next to the generator, with very little clearance to the side fences.

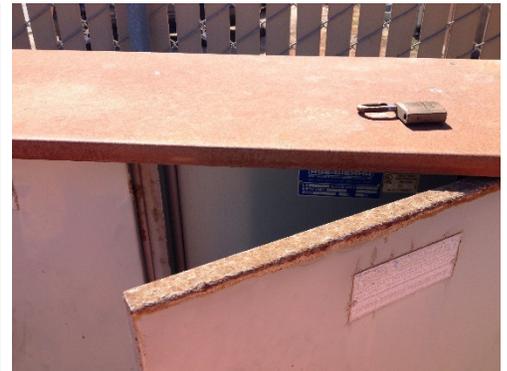
Component
NEMA 3R equipment enclosure
Score
3
Reason
Weathered, faded, and moderate rust.

The exterior surface of the NEMA 3R equipment enclosure is weathered and faded with a uniform layer of light rust on the top surface. The edges around the top of the enclosure and around the access doors have moderate rust, but the enclosure is otherwise in serviceable condition.

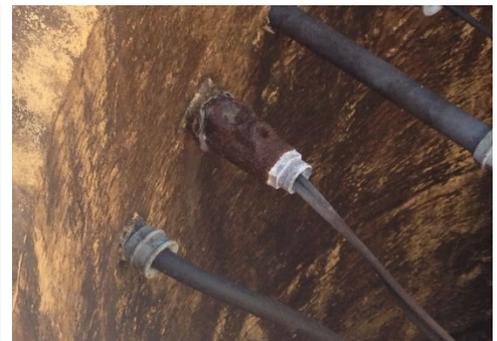
Component
Conduit
Score
3
Reason
Fittings show moderate corrosion, only one conduit has explosion proof fittings.

Only one conduit entering the wet well is terminated with explosion-proof fittings. The fitting shows moderate corrosion.

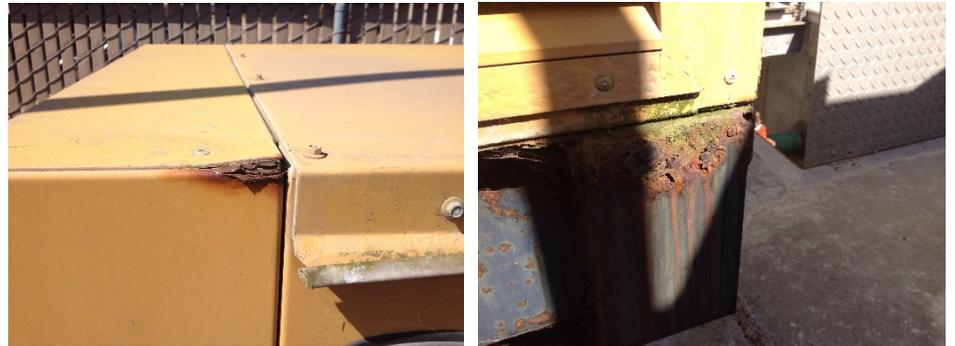
Component
Generator
Score
3
Reason
Moderate to heavy rust

An Olympian model D20P2 diesel engine-generator set, rated at 20 kilowatts/ 25 kilovolt-amps, is located on an adjacent side of the valve pit at the rear of the site. The generator is equipped with a 60-gallon, UL-listed dual-wall subbase tank, and a sound-attenuating enclosure. The generator enclosure and tank have localized areas of moderate-to-heavy rust.

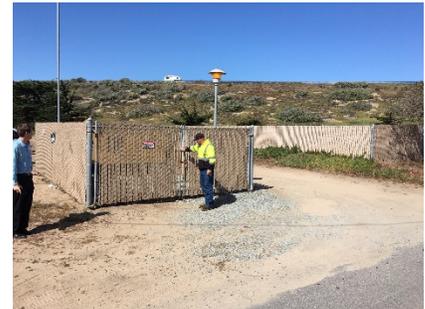
Component
Road Space
Score
2
Reason
Access to valve pit and backup generator is difficult

The site is unpaved and is close to a residential area and San Pablo Court. Since there is adjacent open area to the lift station, there is adequate space for vehicle turnaround. However, access to the valve pit and backup generator is difficult since they are located behind the wet well. The wet well hatch is not strong enough to support a service vehicle (See Hatches in Section 4.2.2), and the gooseneck ventilation outlet on top of the wet well impedes truck access to the back of the site.

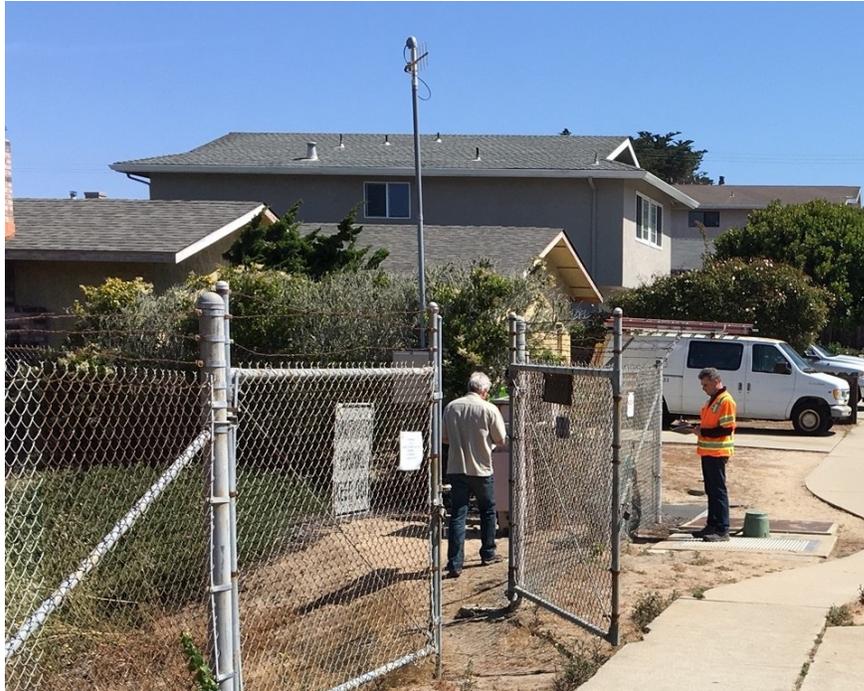
### 4.3 CRESCENT

The Crescent Lift Station is a wet well submersible lift station with no building. Valves and pipes are below grade. Electrical cabinets are above grade. While the electrical cabinets are fenced off, the wet well and valve pit are located outside the fence near a residential sidewalk.

The Crescent Lift Station is located at 3009 Crescent Street, next to a storm water detention pond. The lift station was built in 1977 to serve the local residential area along Crescent Street and Vera Lane, where the low ground elevation prevents gravity flow to Reindollar Avenue.

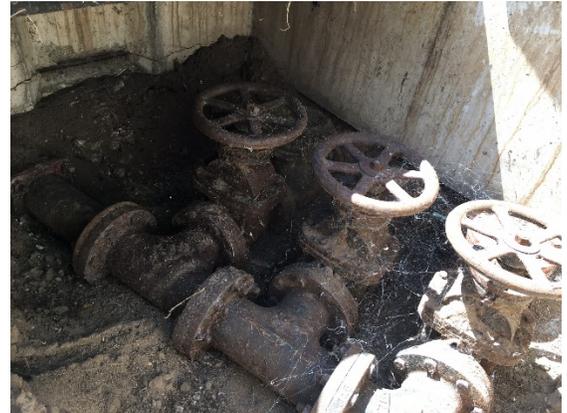
Component
Valve Pit
Score
4
Reason
Valve pit and components within need to be replaced.

The interior of the valve pit shows signs of cracking and surface damage. The valve pit hatch and the hatch rim are rusty. The bottom of the valve pit is filled with sand. The valve pit should be replaced.

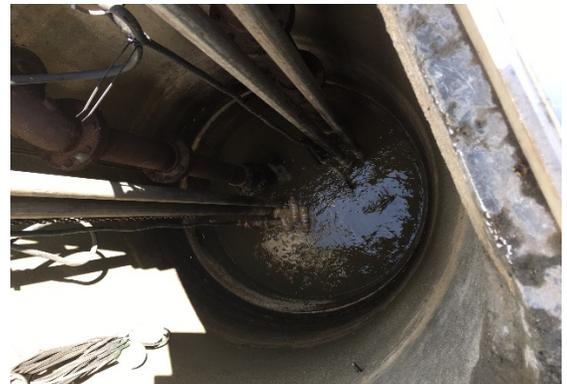
Component
Discharge Pipe and Guide Rails
Score
2
Reason
Discharge pipes show signs of corrosion.

The discharge pipes inside the wet well show signs of corrosion, while the pump lifting guide rails appear to be in good condition.

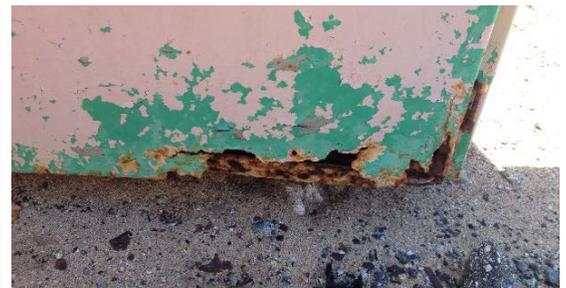
Component
Pump Control Panel
Score
3
Reason
Lower corner of front door is rusted through.

The lower corner of the pump control panel front door is rusted through.

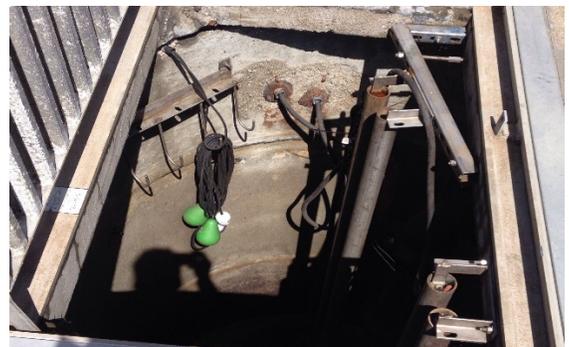
Component
Float Switches
Score
4
Reason
Cables are coiled up and hung above the wet well operating range.

High-level and low-level float switches are installed, but the cables are coiled up and hung on a hook well above the wet well operating range.

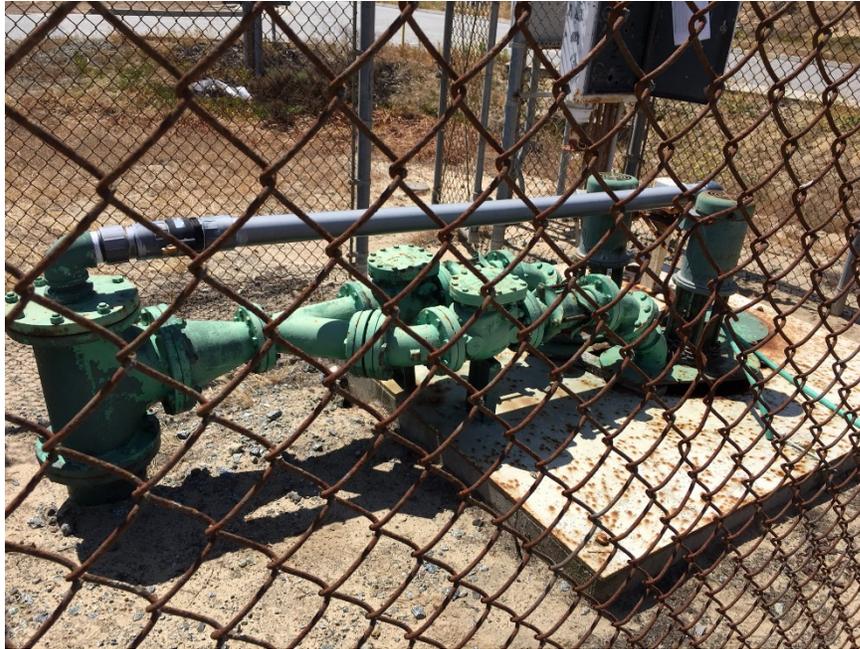
## 4.4 NEESON

The Neeson Lift Station is a wet well submersible lift station with no building. Valves and pipes are above grade. Electrical cabinets are above grade. The entire lift station is fenced in with limited space.

The Neeson Lift Station is a float actuated duplex package sump type lift station that has one pump and a total capacity of 0.58 MGD (400 gpm). It is recommended that a complete lift station replacement be performed.

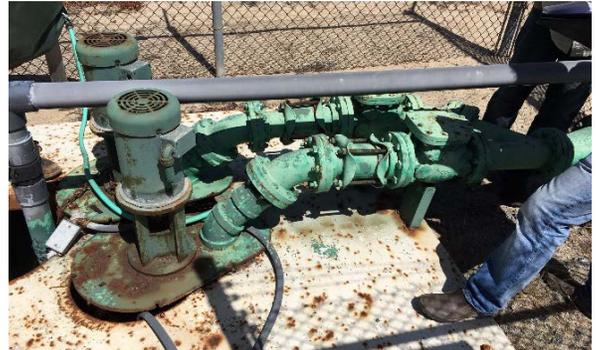
Component
Pump Bypass
Score
5
Reason
Bypass is permanent. Not recommended.

The lift station appears to be in permanent bypass, which is not recommended

Piping and valves show signs of corrosion both inside the well and on the discharge side (For Photo - See Bypass Pump in Section 4.4.1.) of the pump station.

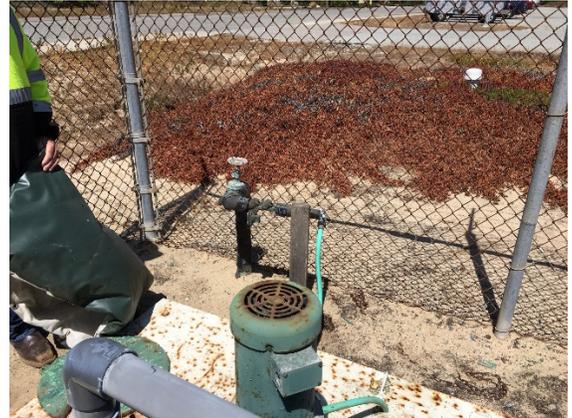
Component
Domestic Water Hose Bib
Score
1
Reason
Backflow Prevention Device was installed.

The domestic water hose bibb within the fence did not have a backflow prevention device accepted by the California Code; this was corrected as of the 2005 Wastewater Collection System Master Plan.

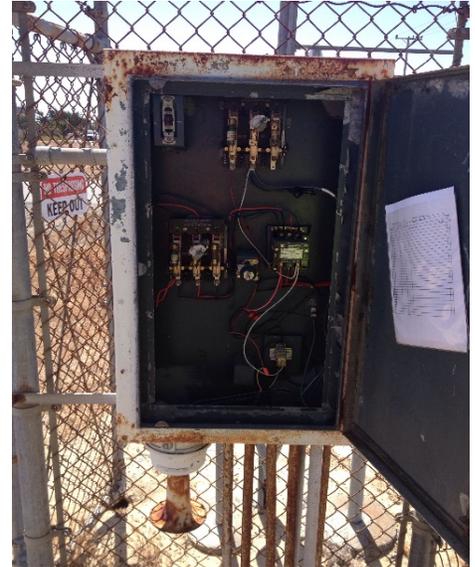
Component
General Electrical Equipment
Score
5
Reason
In poor condition and not functioning.

Electrical equipment appears to be in poor condition and not functioning.

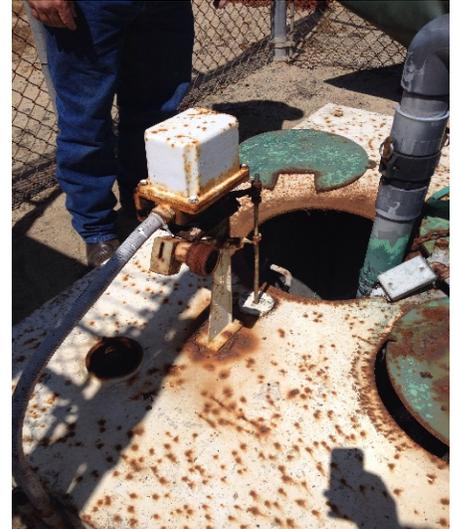
Component
Level Control
Score
4
Reason
Appear to be in poor condition and in need of replacement.

Level control is provided by a float on a vertical rod, which actuates a switch that is mounted above the wet well cover. The level control appears to be in poor condition and in need of replacement.

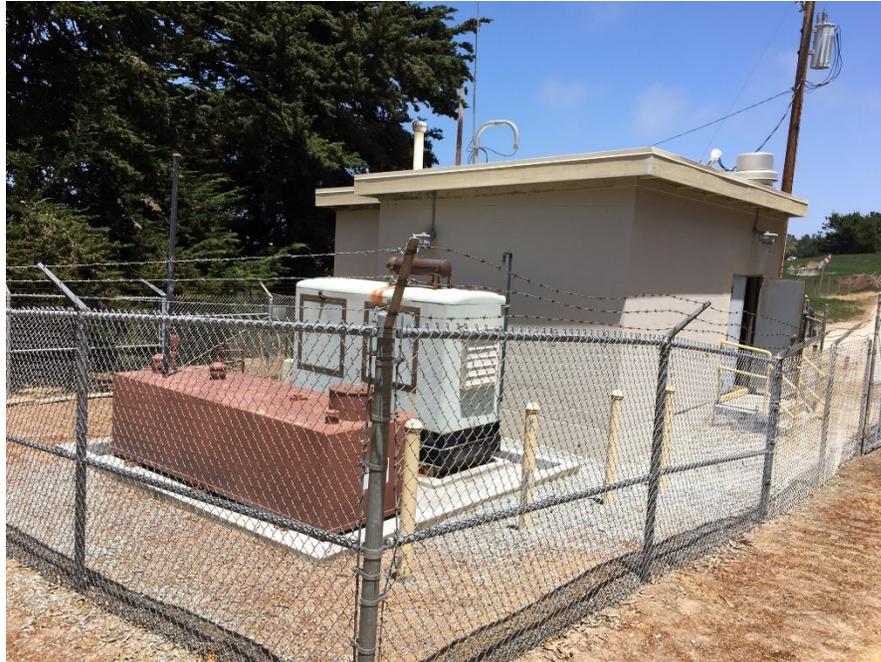
## 4.5 GIGLING

The Gigling Lift Station is a dry pit/wet well lift station with a building. Valves and pipes are in the dry pit below the building. Electrical cabinets are inside the building. The entire lift station is fenced in.

Maximum Capacity is 1.22 MGD (850 gpm).

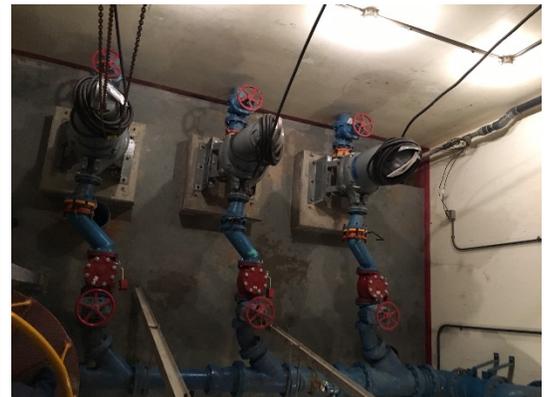
Component
Pumps
Score
1
Reason
No issues observed.

The lift station has three pumps that together run at a maximum capacity of 1.22 MGD (850 gpm), and a TDH of 100 ft. The Flygt submersible pumps were converted to dry pit service. A sump pump in the dry pit has a capacity of 0.07 GPD (50 gpm).

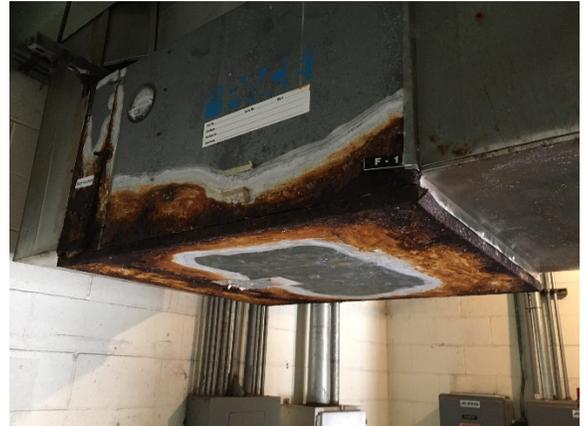
Component
Metal Ducts
Score
3
Reason
HVAC reported to work properly, but there are signs of corrosion.

Though the HVAC was reported to be working properly, there appears to be signs of corrosion.

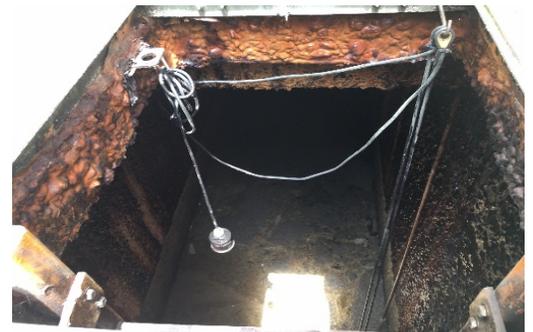
Component
Wet Well Walls
Score
1
Reason
Appear to be in good condition, though covered with an epoxy coating.

The wet well was epoxy coated, and although there is a bumpy coating to the walls, the walls are in good condition, and may have had coating over rough aggregate. The wet well dimensions are 22-ft long, 8-ft wide, and 16-ft deep.

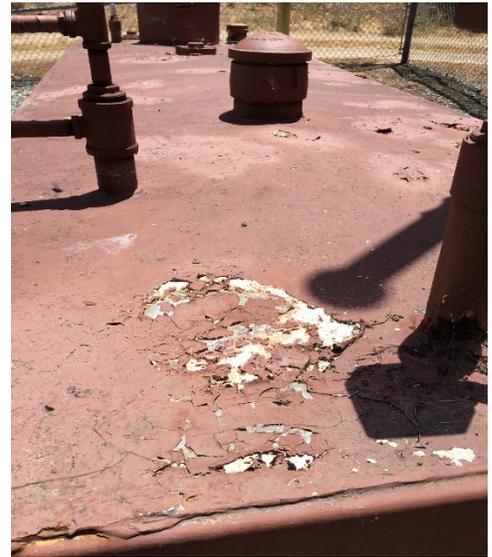
Component
Bulk Tank
Score
3
Reason
Signs of paint deterioration observed.

Signs of paint deterioration were observed on the top of the bulk fuel tank.

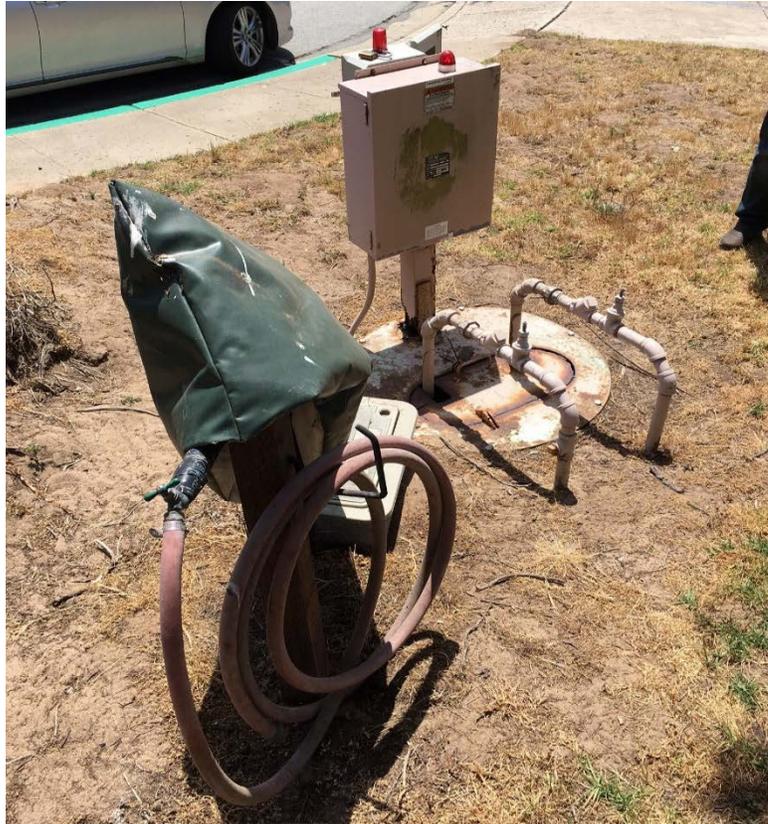
## 4.6 HATTEN

The Hatten Lift Station is a packaged duplex submersible lift station with no building. Valves and pipes are above grade. Electrical cabinets are above grade. The entire lift station has no fence, and is located at the end of the front yard of a residential home. The Hatten Lift Station was construction in 1966, and is controlled by a float system with a capacity of 40 gpm.

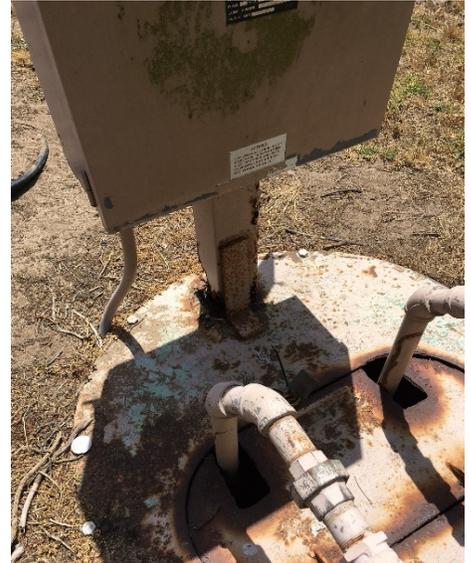
Component
Base Support
Score
5
Reason
Panel is corroded at the base, in danger of falling over. No concrete slab

Structural support is inadequate. It is recommended to have a concrete slab for proper pipe support. In addition, the packaged lift station panel appears to be corroded at the base and is in danger of falling over.

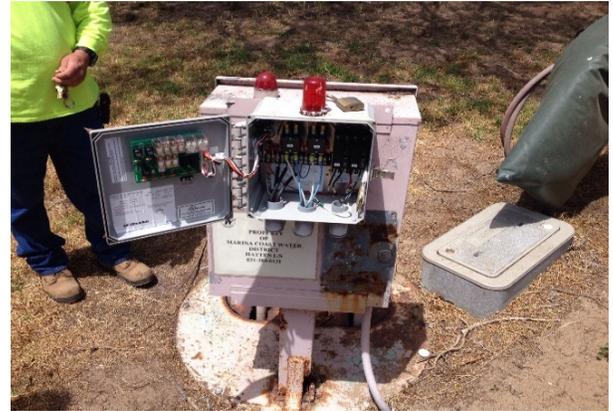
Component
PLC/Telemetry
Score
3
Reason
No PLC/telemetry package. No audible device for alarm notification.

This site is not equipped with the PLC/telemetry package that is present at the other pump stations. The control panel is equipped with two red lights for alarm notification. The presence of an audible device was not noted.

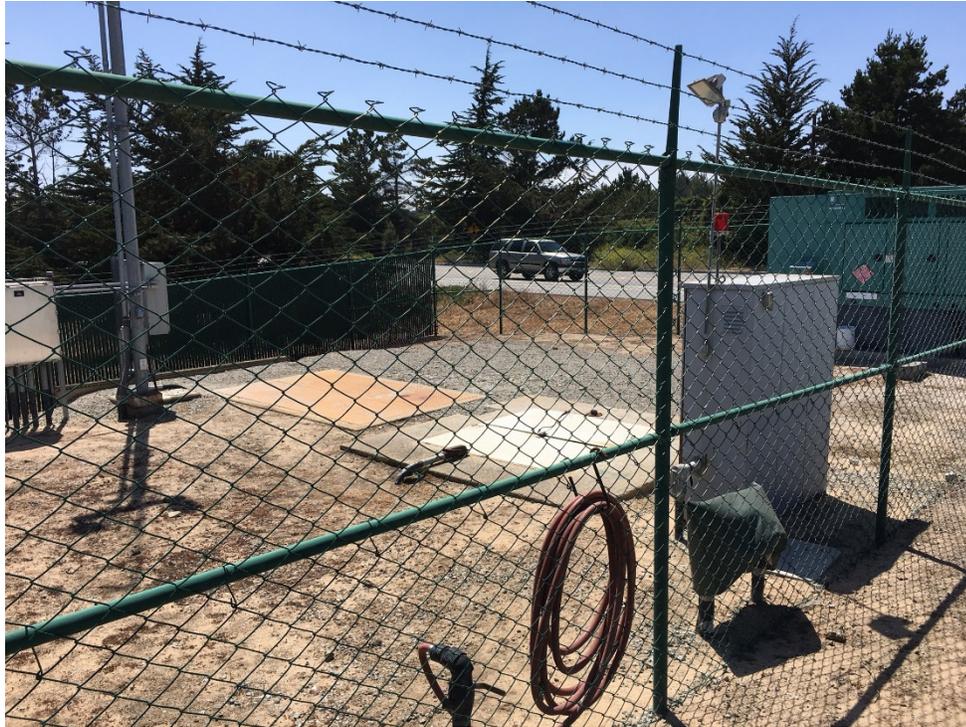
## 4.7 IMJIN

The Imjin Lift Station is a wet well submersible lift station with no building. Valves and pipes are below grade. Electrical cabinets are above grade. The entire lift station is fenced in.

The Imjin Lift Station is currently the largest lift station in the Ord Community sanitary sewer system, and is projected to more than double in size in the future. This key lift station is a critical facility for proper system operation. The Imjin Lift Station was built in 1970, replaced in 1982, and renovated in 2003 with an upgrade of two new 1,490-gpm pumps and associated pump 7 control equipment<sup>2</sup>. It is located alongside Imjin Road east of Abrams Drive. The arrangement of multiple gravity and force main inlets make isolation of the wet well for cleaning or maintenance very difficult.

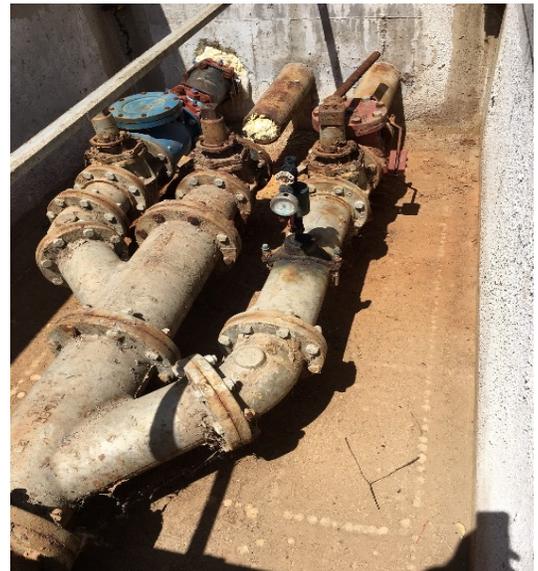
Component
Valve Vault Piping and Valves
Score
4
Reason
High amounts of corrosion. Recommended replacement.

Two new Flygt pumps have a 6-inch diameter ductile iron discharge pipe with a gate valve and a check valve. The discharge pipes combine in a valve pit, and a 10-inch diameter force main conveys flow to the Abrams Trunk Sewer. Only one of the discharge pipes are currently used, thus emergency bypass is not possible. The piping and valves in the valve vault show high amounts of corrosion, and it is recommended to replace all parts within the vault.

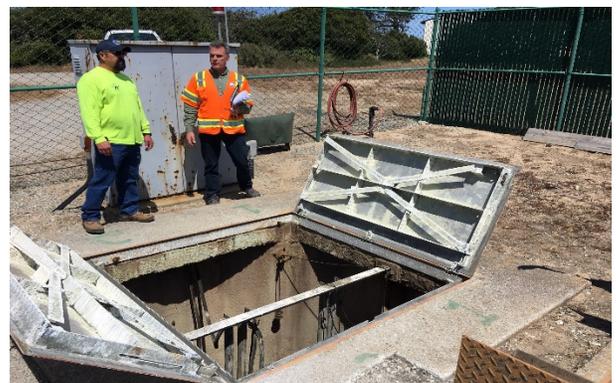
Component
Fall Protection
Score
3
Reason
Fall Protection is recommended for safety.

The wet well hatch cover is in fair condition, but fall protection is recommended.

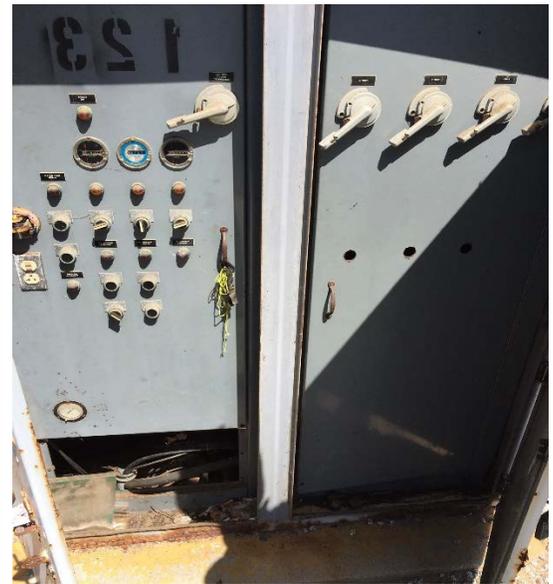
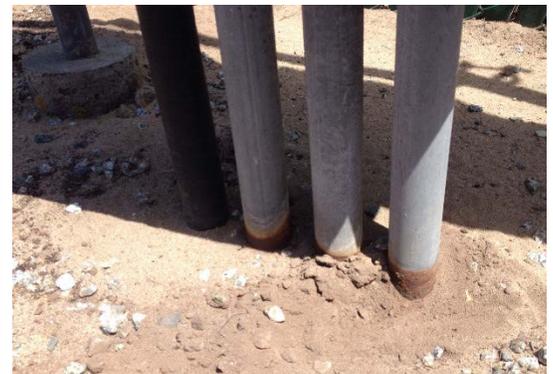
Component	Score	Reason
Meter/main panel	1	No issues observed.
Component	Score	Reason
Automatic Transfer Switch	1	No issues observed.
Component	Score	Reason
Pump Control Panel – prior to 2003 upgrades	3	Consider removing in favor of an underground pullbox or handhole.
Component	Score	Reason
Current Pump Control Panel	3	Conduits have rust where in contact with the soil.
Component	Score	Reason
480:208/120V unit power center	1	No issues observed.

The electrical equipment consists of a meter/main panel, automatic transfer switch, pump control panel, and a 480:208/120V unit power center with stepdown transformer and breaker panel. The pump control panel contains a Zenith Pulsar level controller and combination full-voltage, non-reversing two motor starters. The pump control panel is weathered, but in otherwise good condition. Galvanized conduits extending from underground were not properly wrapped during installation, causing the conduits to rust where in contact with soil.

The pump control panel that existed prior to the 2003 upgrades has been repurposed essentially as a pullbox for the generator and pump motor feeders. It is in fair-to-poor condition, but serves the current purpose. The District should consider removing this panel in favor of an underground pullbox or handhole.

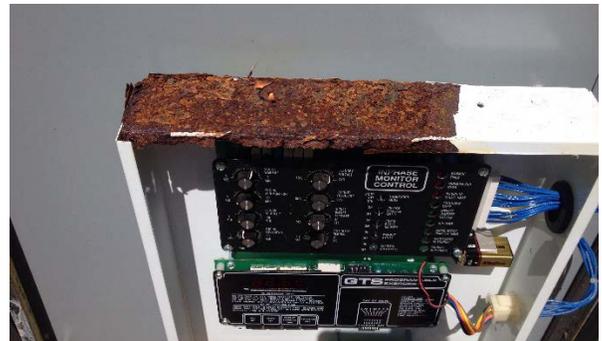
Component
Outer enclosure of the automatic transfer switch.
Score
3
Reason
Severe rust to the metal enclosures that protects the ATS control boards.

The outer enclosure of the automatic transfer switch is rusted through in two places at the drip edge above the door. Water is dripping inside, causing severe rust to the metal enclosure that protects the ATS control boards. It is a matter of time before the rusted metal no longer protects the control boards from the dripping water.

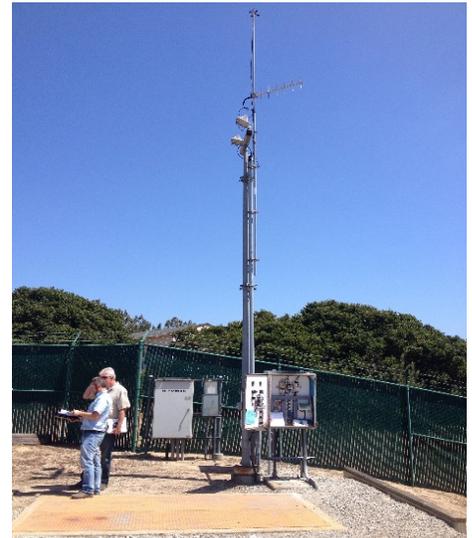
Component
Second Antenna
Score
3
Reason
Unknown purpose from District personnel

A second antenna, appearing similar to a remote cellular antenna, is mounted at the top of the mast. Cabling from this antenna is routed in underground conduit, and could not be traced. The antenna cable was not observed in any of the equipment enclosures. District personnel also were unsure of its purpose.

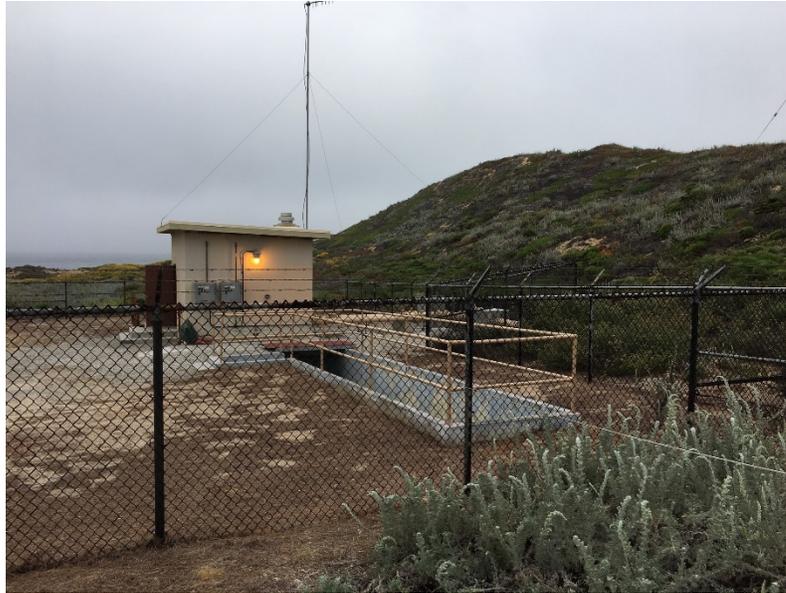
## 4.8 ORD VILLAGE

The Ord Village Lift Station is a dry pit/wet well lift station with a building. Valves and pipes on the discharge side are outside the building. Electrical cabinets are both inside and outside of the building. The entire lift station is fenced in.

The Ord Village Lift Station is the only District lift station located on the west side of Highway 1, the Union Pacific Railroad (UPRR), and Beach Range Road. This lift station, which was initially a sewage treatment plant that provided wastewater treatment for Fort Ord and was constructed prior to 1960, is situated near the shoreline of Monterey Bay. Lift station reliability is critical because, if an overflow were to occur, untreated wastewater would quickly reach the sensitive ocean habitat.
