# Marina Coast Water District Sewer Master Plan

**AKEL**  
ENGINEERING GROUP, INC.

**SEWER MASTER  
PLAN**

May 2020

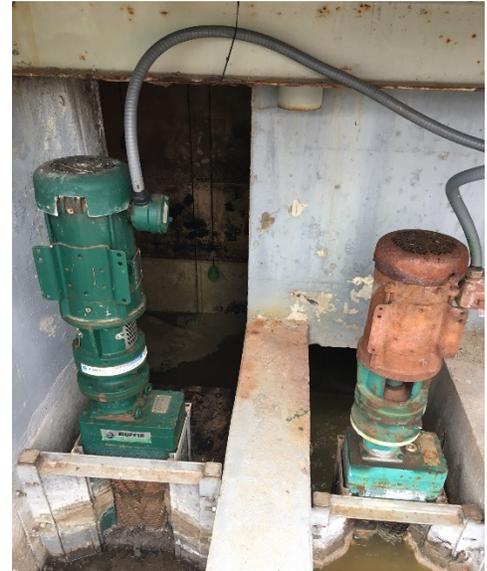
Component
Muffin Monster Comminutors
Score
3
Reason
One comminutor is highly corroded and recommended to be replaced.

Prior to being converted to a lift station, the Ord Village facility was a wastewater treatment plant. Two open influent channels enter the lift station wet well. Each influent channel is fitted with a Muffin Monster comminutor. The comminutors have 3-hp electric motors with 18-inch helical stack cutters to grind solids into smaller portions for easy passage through the pumps. One of these is highly corroded and is recommended to be replaced (see photo above).

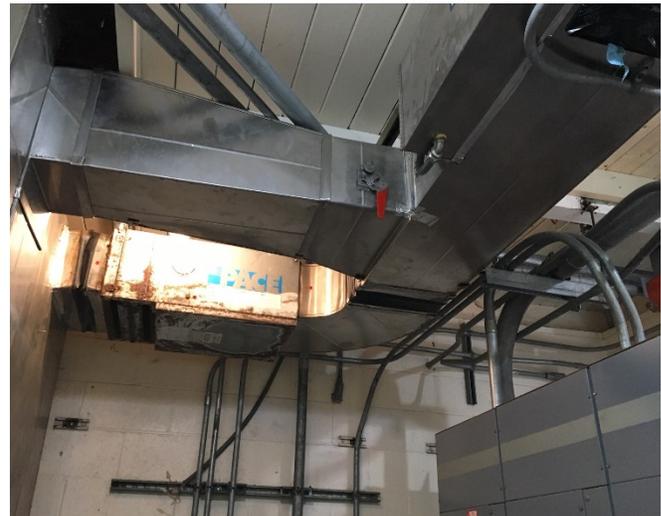
Component
Metal Ducting
Score
3
Reason
Signs of dampness and corrosion. Recommended replacement.

A heating, ventilation, and air conditioning (HVAC) system is also provided to provide ventilation in the below ground areas and to dehumidify the air within the lift station control building (to reduce corrosion and to increase personnel safety). The HVAC system includes a PACE F-1 supply fan, a Baldor 1/3-hp, 530 cfs motor, and a Penn EF-1 exhaust fan with 1/4-hp Marathon motor. Stainless steel ducting draws air from the dry well and

the lift station control room and exhausts the air outside the building. In several locations, especially near the exit wall, the ducting shows signs of dampness and corrosion and is recommended to be replaced.

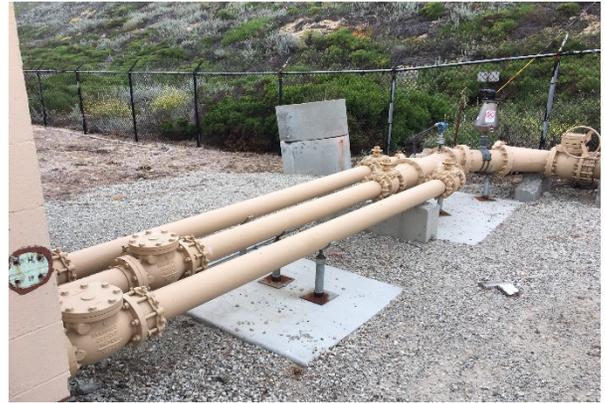
Component
Piping and Valves
Score
1
Reason
New pipes and valves

Piping and valves on the discharge side of the pump station are new.

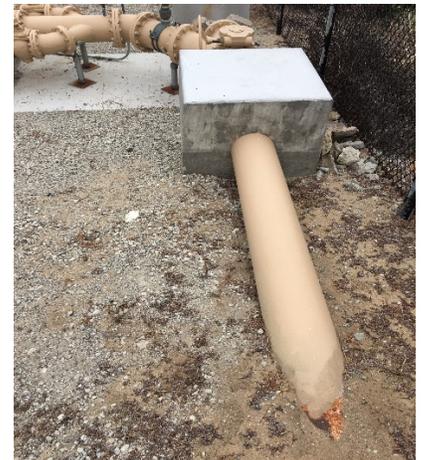
Component
Pipe at end of discharge line
Score
3
Reason
Corrosion – recommended recoat or replacement.

In general, piping and valves appear to be adequate. There does, however, appear to be corrosion at the end of the discharge line, and it is recommended to recoat or replace this section. The extent of exterior corrosion on the pipe is unknown beyond the limits shown in the photo above.

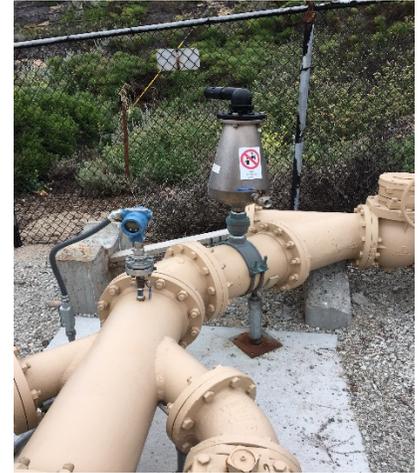
Component
Air Lock issues - Piping / Valves
Score
3
Reason
Force main causing air issues in piping

For this station and for the Gigling Lift Station, even with new pumps installed, there are air lock issues due to problems with the force main. The District reported breaks in the force main. Due to this, the District has been monitoring pressure. There is a lot of bleeding, and sometimes the District will lift up the check valve and backflush before it will prime again. Problems with water hammer have been partially solved by the air release valve. Condition assessment of the force main will require flow handling or bypass. For cost efficiency, condition assessment should be coordinated with other activities at the lift station that necessitate flow handling or bypass.

Due to problems in the force main on the discharge side of the lift station, the operators have a gauge to monitor air pressure. For this station and Fort Ord Village, even with new pumps installed, there are air lock issues. There is a lot of bleeding, and sometimes the District will have to lift up the check valve and backflush before it will prime again. Condition assessment of the force main is recommended to address the air lock issues in the piping at the lift station.

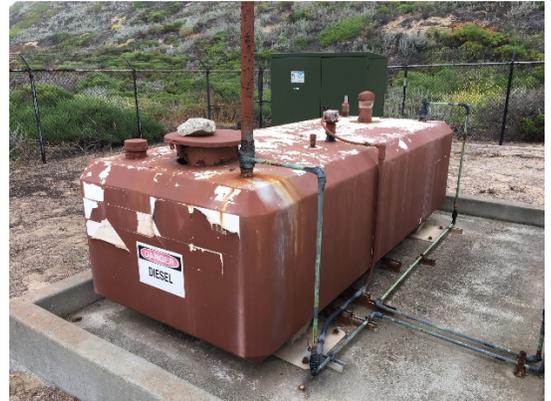
Component
Concrete Slabs on grade
Score
1
Reason
Appear to be in good condition

Concrete slabs-on-grade are provided for the generator, fuel storage tank, and outdoor electrical facilities.

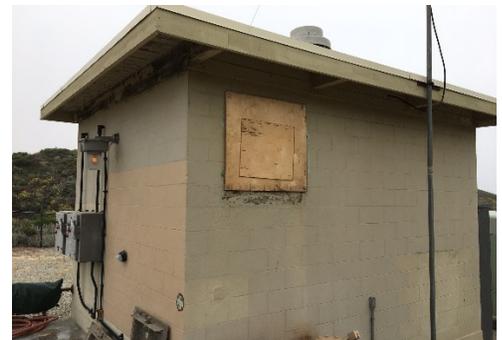
Component
Wall Penetration Replacement
Score
3
Reason
Wall appears to have a boarded up louver or duct penetration. Repair of this location is recommended.

One wall appears to have a boarded up louver or duct penetration with a wood plank and may need to be replaced.

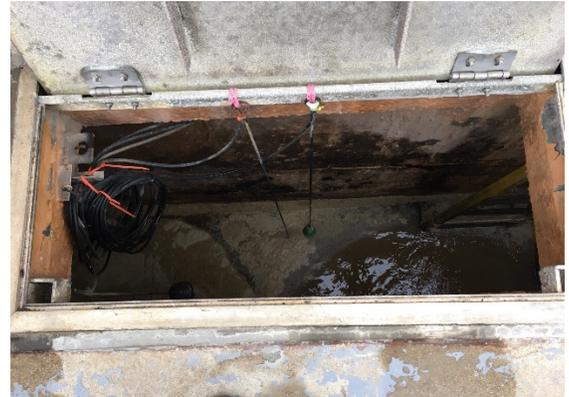
Component
Wet Well Hatch
Score
3
Reason
Operator mentioned wet well is difficult to clean. Larger hatch is recommended.

Dimensions of the wet well are 12-ft long, 6-ft wide, and 11-ft deep. The wet well structure appears to be in good condition, but the operator mentioned it is difficult to clean. A larger hatch is recommended.

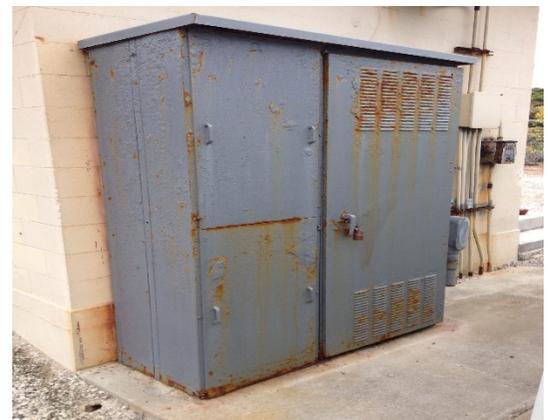
Component
Service entrance switchboard
Score
3
Reason
Heavily rusted

The service entrance switchboard consists of a utility underground pull section, and a PG&E metering compartment and main breaker. The switchboard, mounted on a pad outside the building, is heavily rusted. It is recommended to replace the rusted mild-steel main service entrance enclosure located on the west side of the pump building with a stainless steel enclosure.

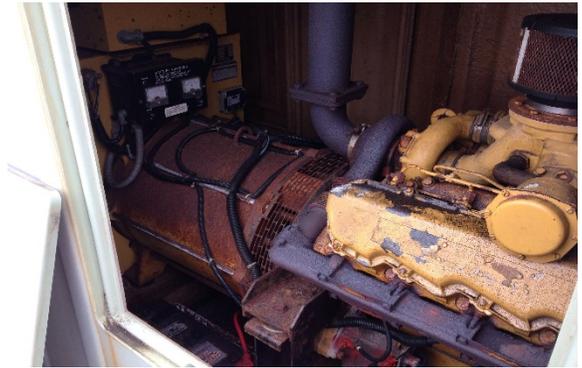
Component
Alternator Housing
Score
4
Reason
Heavily rusted. Small pieces of rusty metal could short out the tank.

The exterior of the alternator housing is heavily rusted, causing one to hypothesize that the housing interior is also heavily rusted, perhaps to the point that small pieces of rusty metal could flake off and potentially short out the generator windings or cause other modes of failure. The fiberglass outer enclosure is heavily weathered. The spill basin on the diesel bulk tank is rusted through, and the paint on the tank is failing. As mentioned above, the leak detection panel is in poor condition, and likely does not function. These elements should be replaced to ensure reliability of the backup power system.

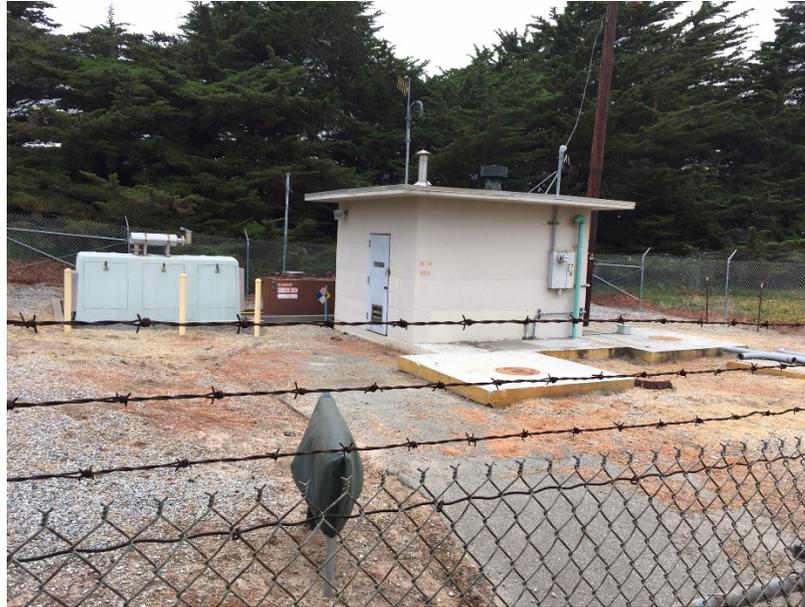
The Booker Lift Station is a dry pit/wet well lift station with a building. Valves and pipes on the discharge side are below the building. Electrical cabinets are both inside the building. The entire lift station is fenced in.

Booker Lift Station was constructed in approximately 1966 and was upgraded in 1997. The lift station has a total capacity of 760 gpm with two pumps, but only one operable pump was reported from District staff. It is a dry pit/wet well type lift station and is controlled by a sonic level sensor. The service area is planned to be redeveloped, and major rehabilitation or replacement of the lift station is recommended.

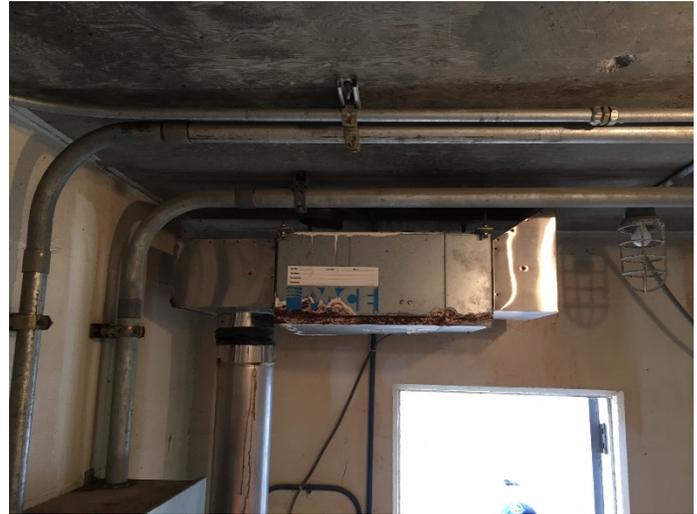
Component
Redesign of HVAC system
Score
5
Reason
Exhaust fan discharges into the building. Strong odor inside the building. Potentially hazardous condition.

The wet well and dry well vents are connected via a single duct to an exhaust fan that is mounted inside the pump station building. The exhaust fan discharges into the building, not outside. This creates a strong odor problem inside the building, essentially negates the attempt to ventilate the dry well, and potentially creates a hazardous condition inside the pump station building. The ventilation system needs to be redesigned to effectively achieve the pump station's ventilation goals.

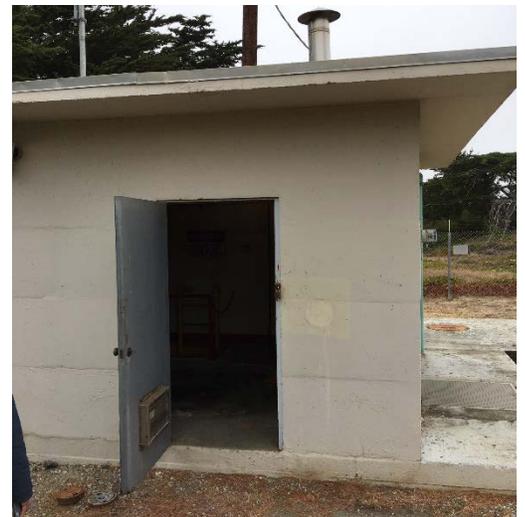
Component
Door
Score
1
Reason
Appears to be in decent condition.

The door appears to be in decent condition. For information on hatches see Wet Well / Dry Pit in Section 4.9.1. There are no windows.

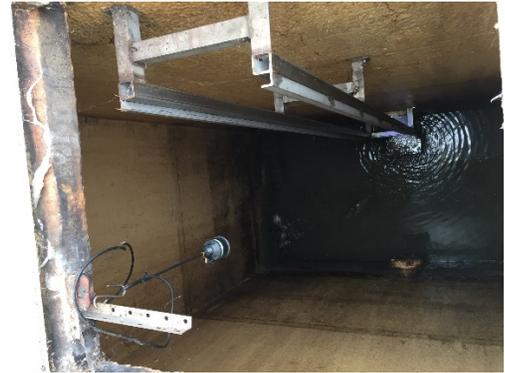
Component
Wet well coating
Score
2
Reason
Appears to be in decent condition.

The coatings on the wall appear to be in good condition. Wet well dimensions are 13-ft long, 6-ft wide, and 20-ft deep.

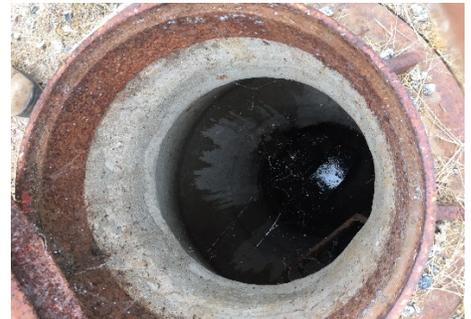
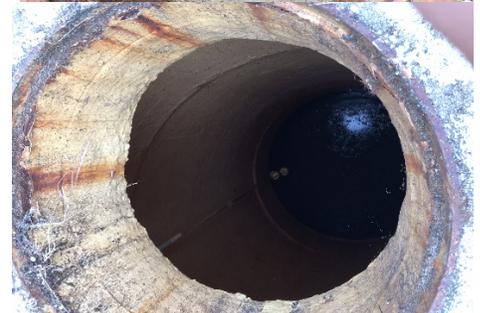
Component
Manhole 1
Score
1
Reason
Walls appear to be in good working condition.

Component
Manhole 2
Score
1
Reason
Walls appear to be in good working condition.

On both sides of the wet well there are manholes. The walls appear to be in good working condition.

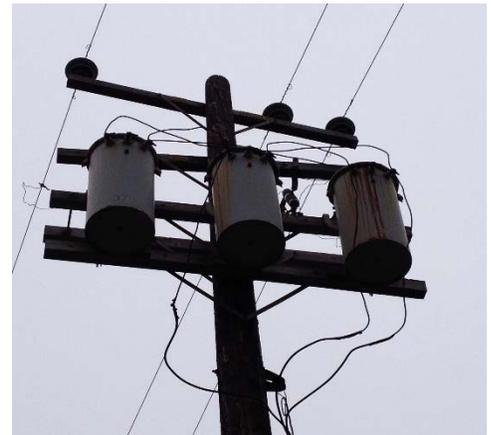
Component
Pole mount transformer
Score
3
Reason
Electrical service should be upgraded to meet PG&E's current standard for a 480V system.

The lift station electrical distribution system is fed from three single-phase pole-mount PG&E transformers, located within the lift station fence. The service is rated at 200-amps, 480 volts, three-phase, three-wire. A surge protection capacitor is mounted at the service panel, perhaps as an attempt to provide capacitive grounding to the otherwise ungrounded system. The electrical service should be upgraded to meet PG&E's current standard for a 480V system and to create a safer system for District personnel to operate and maintain.

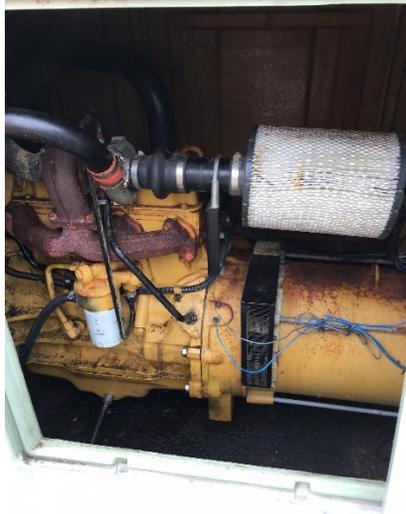
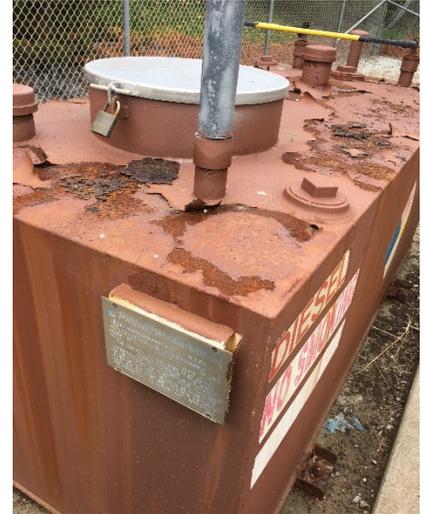
Component
Generator
Score
4
Reason
Reported to have engine valve problems and not in operating condition.
Component
250 gallon bulk diesel fuel tank
Score
4
Reason
Heavily rusted

The generator is reported to have engine valve problems and to not be in operating condition. The 250-gallon bulk diesel fuel tank site is heavily rusted. These elements should be replaced.

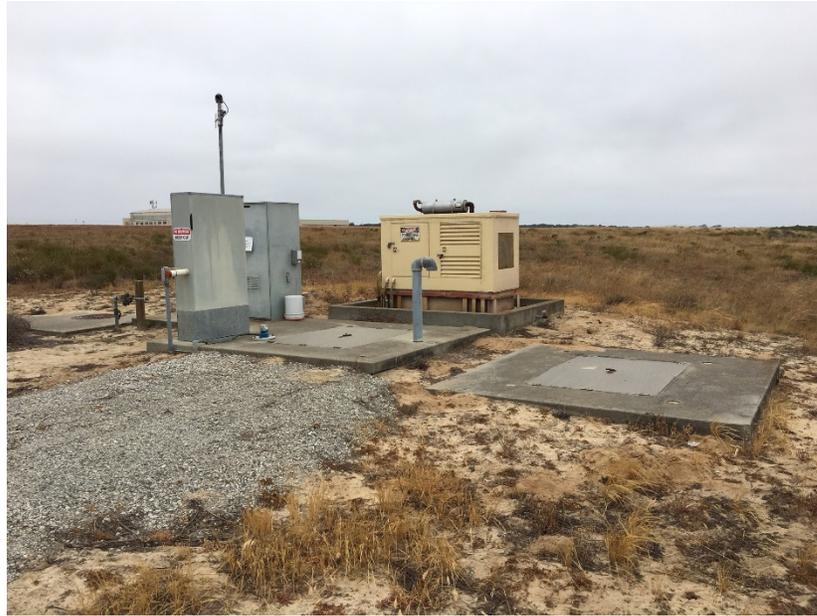
The Fritzche Lift Station is a wet well submersible lift station with no building. Valves and pipes on the discharge side are below grade. Electrical cabinets are mounted at grade. The lift station is not fenced in, though it is inside an airfield, which has perimeter fencing and security.

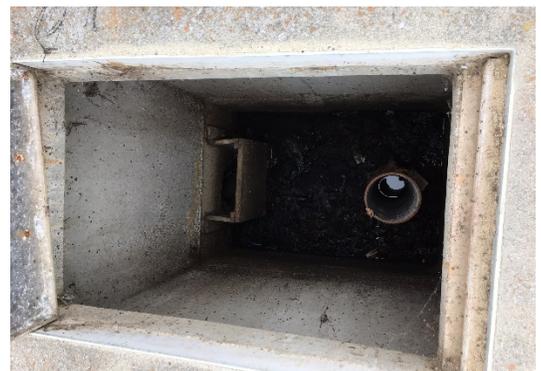
Component
Oil Separator
Score
3
Reason
Needs to be cleaned on a regular basis.

There is an oil separator that appears to be clogged. Cleaning of the oil separator on a regular basis is recommended.

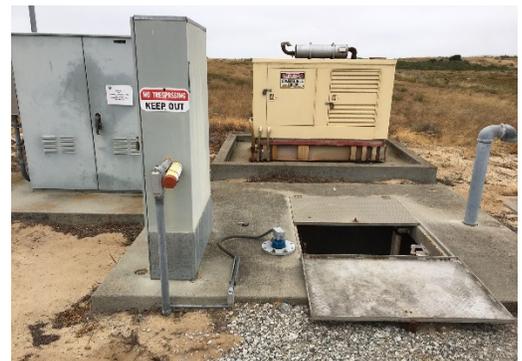
Component
Concrete Slabs
Score
2
Reason
Appear to be on grade and in decent condition

Concrete slabs appear to be on grade and in decent condition.

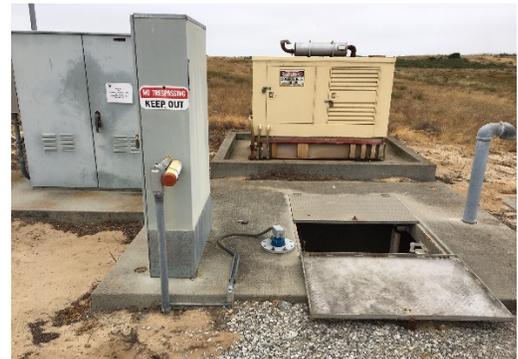
Component
Pad mount transformer
Score
1
Reason
Appear to be on grade and in decent condition

Drawings were not available to show the layout of the site electrical distribution system. Conclusions were drawn from what could be observed above ground. The lift station electrical distribution system is apparently fed from a 12kV distribution system that is owned by the airport, and likely feeds other adjacent equipment installations. The pump station appears to be fed by its own 208Y/120V, 3-phase, four-wire pad-mount transformer.

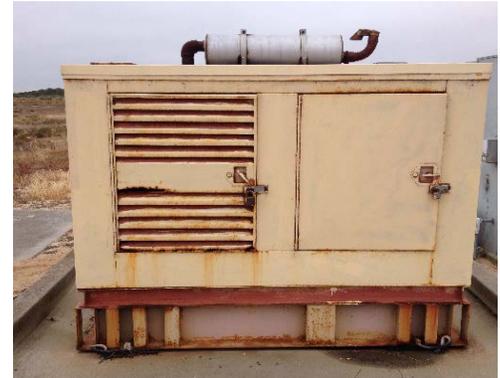
Component
Generator
Score
4
Reason
Enclosure and exposed exhaust system heavily rusted.

The generator enclosure and exposed exhaust system components are heavily rusted. The subbase fuel tank has minor-to-moderate rust. It is recommended for the generator to be replaced.

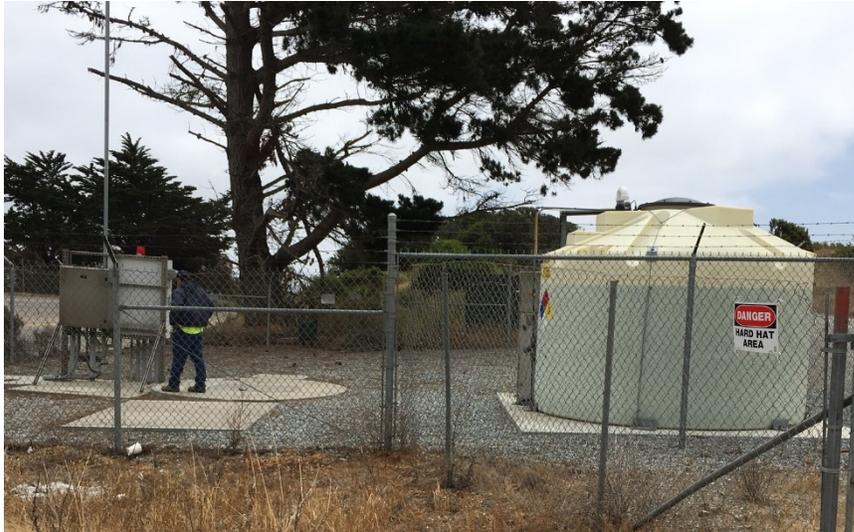
The East Garrison Lift Station is a wet well submersible lift station with no building. Valves and pipes on the discharge side are below grade. Electrical cabinets are above grade. The lift station is fenced in.

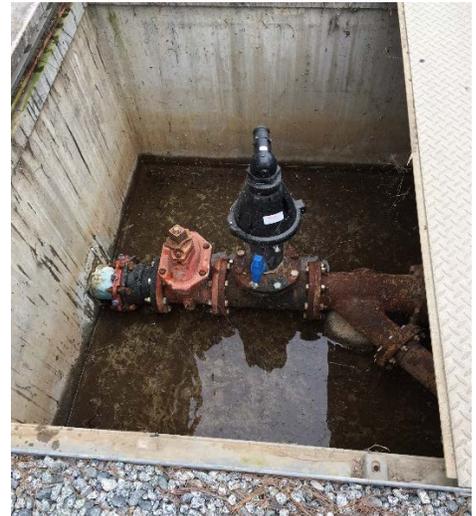
Component
Valve Vault Drainage
Score
4
Reason
Standing water needs to be removed
Component
Valve Vault Pipes and Valves
Score
4
Reason
Piping and Valves heavily corroded.

On inspection the valve vault was seen to have standing water up to the piping. There appeared to be a drain that ran to the wet well, with a closed valve. It is recommended to open the valve and clean out the drain line in order to remove standing water at the valve vault. The piping and valves within the valve vault also appear to be corroded, and are recommended to be replaced.

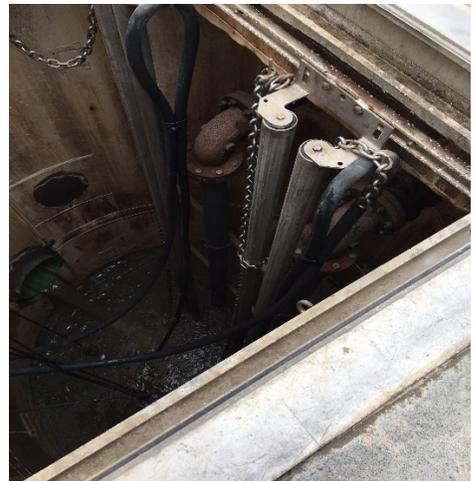
Component
Piping in wet well
Score
4
Reason
Corrosion Issues. Recommended replacement.

Piping appears to have corrosion issues within the wet well, and it is recommended to be replaced.

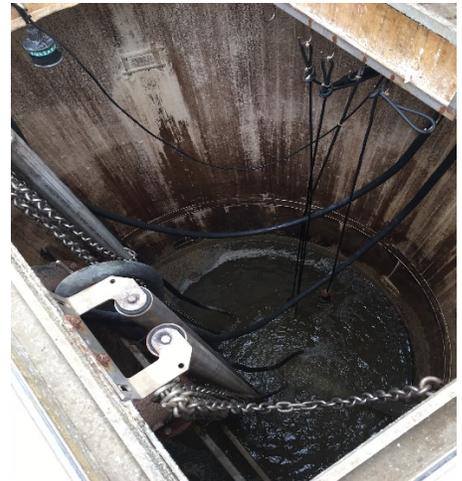
Component
Wet well liner
Score
1
Reason
No issues observed.

The wet well appears to have a liner rather than coating. No issues observed. Wet well dimensions are 8-ft in diameter and 18-ft deep.

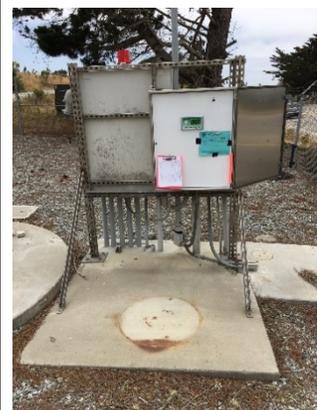
Meter/main panel	1	No issues observed.
Pump control panel	2	Shows minor weathering, otherwise appears to be in good condition.
PVC conduits between the electrical panels and the wet well	3	Appear to be shifting due to subgrade settlement.

The electrical equipment consists of a meter/main panel, and a pump control panel. The pump control panel contains a Zenith Pulsar level controller and combination full-voltage, non-reversing two motor starters. The panels show some minor weathering, but are otherwise appear to be in good condition. The concrete pad on which the electrical panels are mounted appears to be shifting due to subgrade settlement. The PVC conduits between the electrical panels and the wet well may be stressed or broken due to this settlement. It is recommended that the concrete pad and any broken conduits be replaced, and the electrical panels remounted.

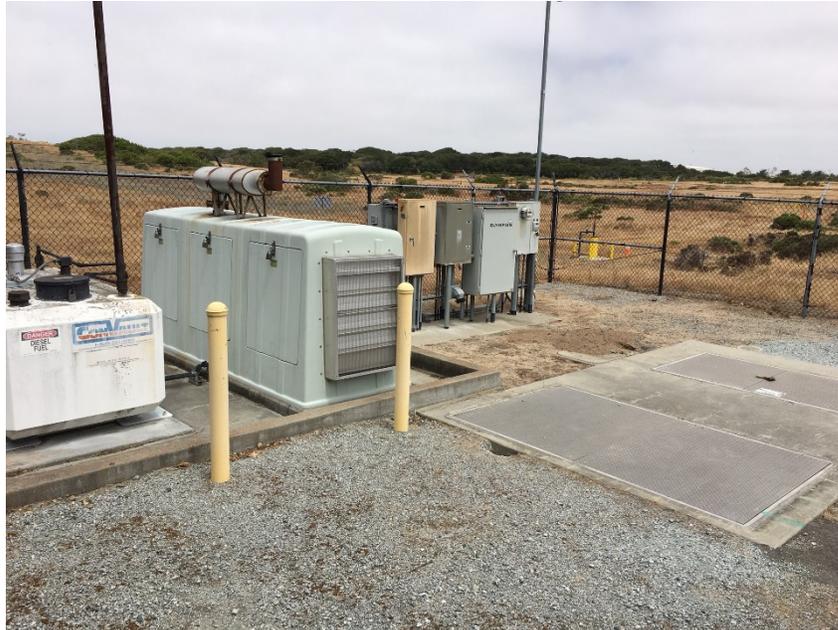
The Reservation Lift Station is a wet well submersible lift station with no building. Valves and pipes on the discharge side are below grade. Electrical cabinets are above grade. The lift station is fenced in.

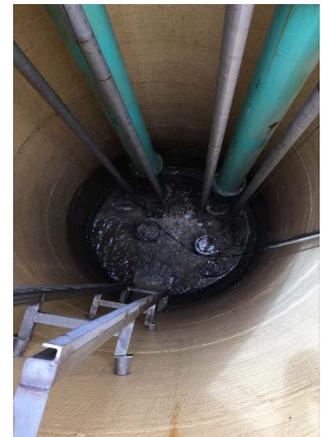
Component
Pumps
Score
1
Reason
No issues observed.

There are two pumps with a maximum capacity of 900 gpm. The wet well water level was lowered for a visual on the pumps. It was confirmed that the pumps were not Flygt models. The operator mentioned that they may have O&M manuals for these pumps. Pumps operate in lead / lag mode.

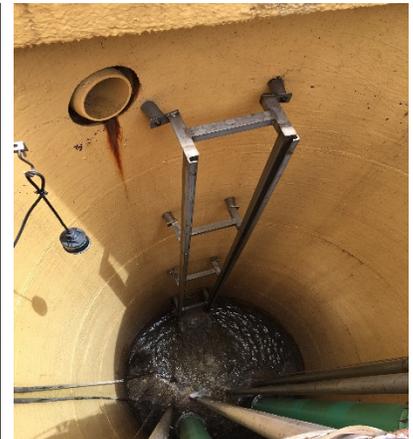
Component
Wet Well Coating
Score
3
Reason
Rust bleed below a drain line

The wet well coating appears to be in good condition, though there is rust bleed below a drain line that is recommended to be recoated. The wet well is 8-ft in diameter and 24-ft deep.

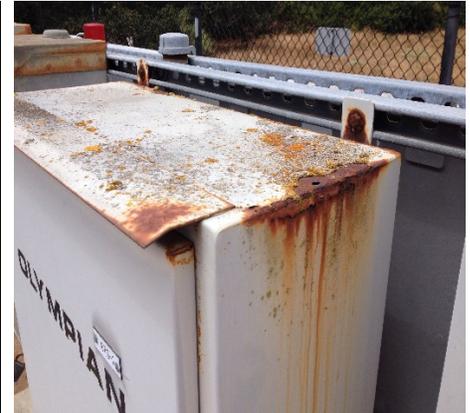
Component	Score	Reason
Meter/main panel	1	No issues observed.
Component	Score	Reason
Automatic transfer switch	3	One area on the enclosure top surface that is rusted through.
Component	Score	Reason
Manual Transfer Switch	1	No issues observed.
Component	Score	Reason
Pump control panel	1	No issues observed.
Component	Score	Reason
480:208/120V unit power center	1	No issues observed.

The electrical equipment consists of a meter/main panel, automatic transfer switch, manual transfer switch, pump control panel, and a 480:208/120V unit power center with stepdown transformer and breaker panel. The pump control panel contains a Zenith Pulsar level controller and combination full-voltage, non-reversing two motor starters. The panels are individually mounted on a unistrut support structure. The panels are weathered, with small areas of light rust but in otherwise good condition. The exception is the automatic transfer switch, which has one area on the enclosure top surface that is rusted through.

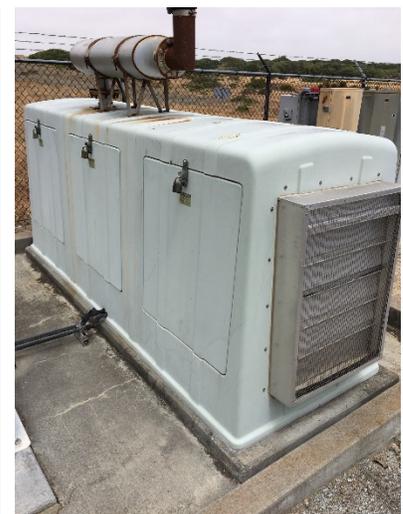
Component
100kW Olympian generator
Score
1
Reason
No issues observed.

The pump station is equipped with a 100kW Olympian generator, which is mounted inside a weather-protective fiberglass enclosure.

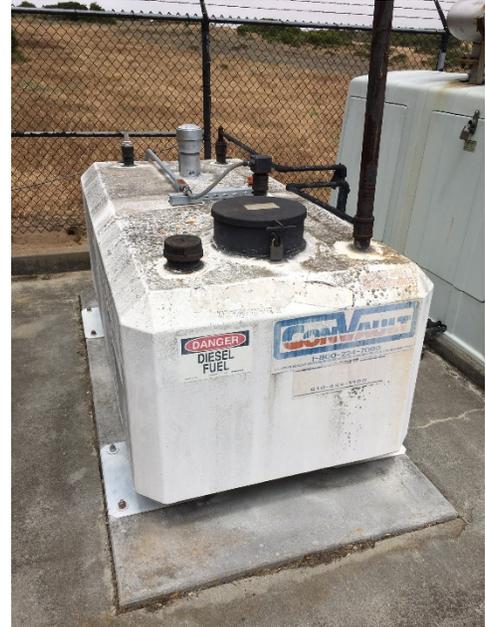
Component
Convault bulk tank
Score
1
Reason
No issues observed.

A Convault bulk tank is located next to the generator. Both the generator and tank appear to be in good condition.

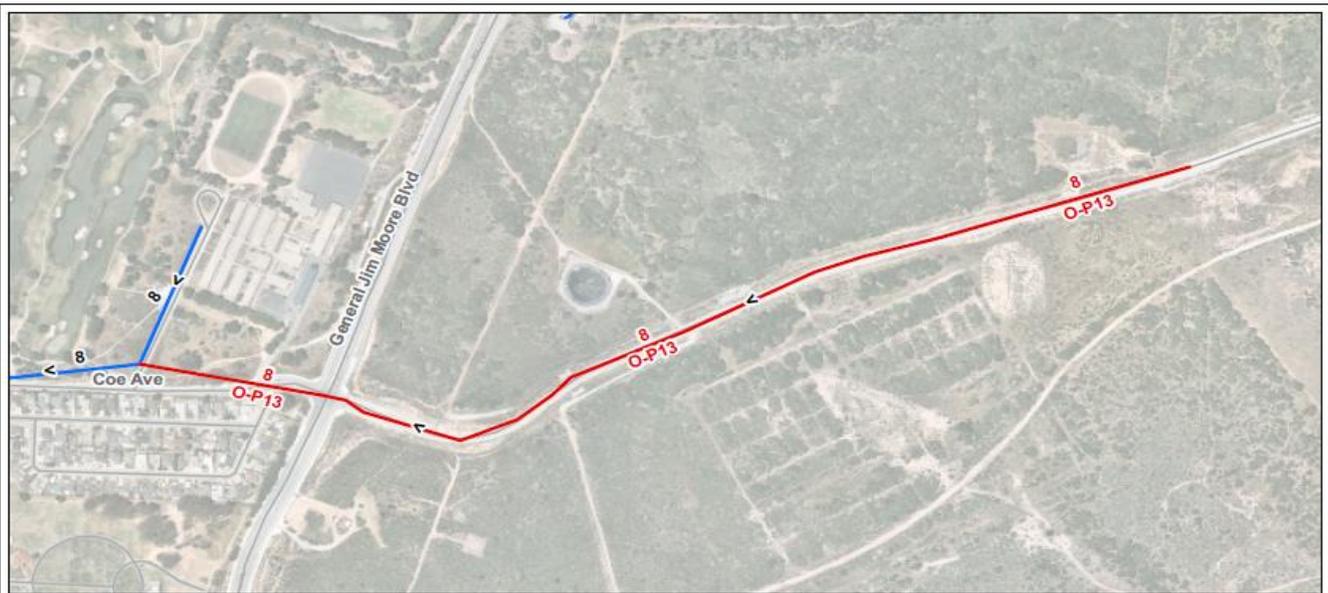
This project includes the construction of a new 8-inch gravity main along Eucalyptus Road from approximately 4,000' east of General Jim Moore Boulevard to approximately 800' west of General Jim Moore Boulevard. This project is planned to serve potential development along Eucalyptus Road.
